The purpose of this study was to evaluate the prevalent damage modes and the predominant cause of failure for both the polyethylene and metallic components of the rotating hinge knee megaprotheses.

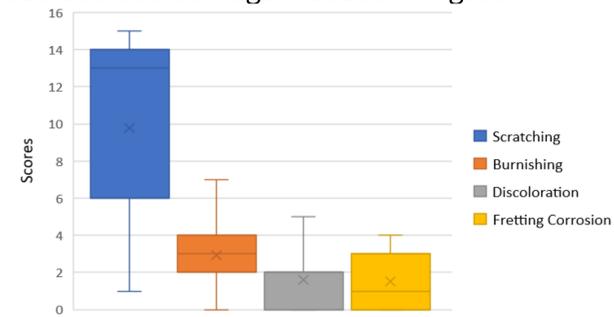
Figure 5. Damage scores for all the metallic components

- Infection was the most predominant revision reason among all the implants.
- Scratching was the most prominent damage mode observed for all the metallic components and fretting corrosion was the least observed.
- For the polyethylene inserts, scratching, pitting and burnishing had the highest recorded damage modes. Abrasion, delamination, surface deformation and embedded debris had the lowest recorded damage modes amongst the polyethylene components.

- Infections being the predominant revision reason is consistent with previous studies that were conducted about implant revisions and failure.
- There was less fretting corrosion observed on the metallic components due to most of them being metal on polyethylene rather than metal on metal implants.
- More damage was observed on the posterior side of the polyethylene compared to the anterior side primarily because of there being far more rotation on the posterior side when compared to the anterior side.

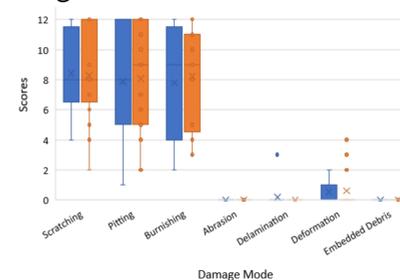
Figure 8. Comparison of Damage on Medial and Lateral side

- No significant difference between medial and lateral side ( $p=0.884$ ) and significant difference between anterior and posterior side ( $p<0.001$ )
