# Surface Damage Mechanisms, *In Vivo* Oxidation, and Reasons For Revision for Highly Crosslinked Tibial Inserts for TKA

<sup>1</sup>MacDonald, D; Higgs, G<sup>1</sup>; <sup>3</sup>Parvizi J;  
<sup>4</sup>Klein, G; <sup>4</sup>Hartzband, M; <sup>4</sup>Levine, H;  
<sup>5</sup>Kraay, M; <sup>5</sup>Rimnac, C; <sup>1,2</sup>Kurtz, SM

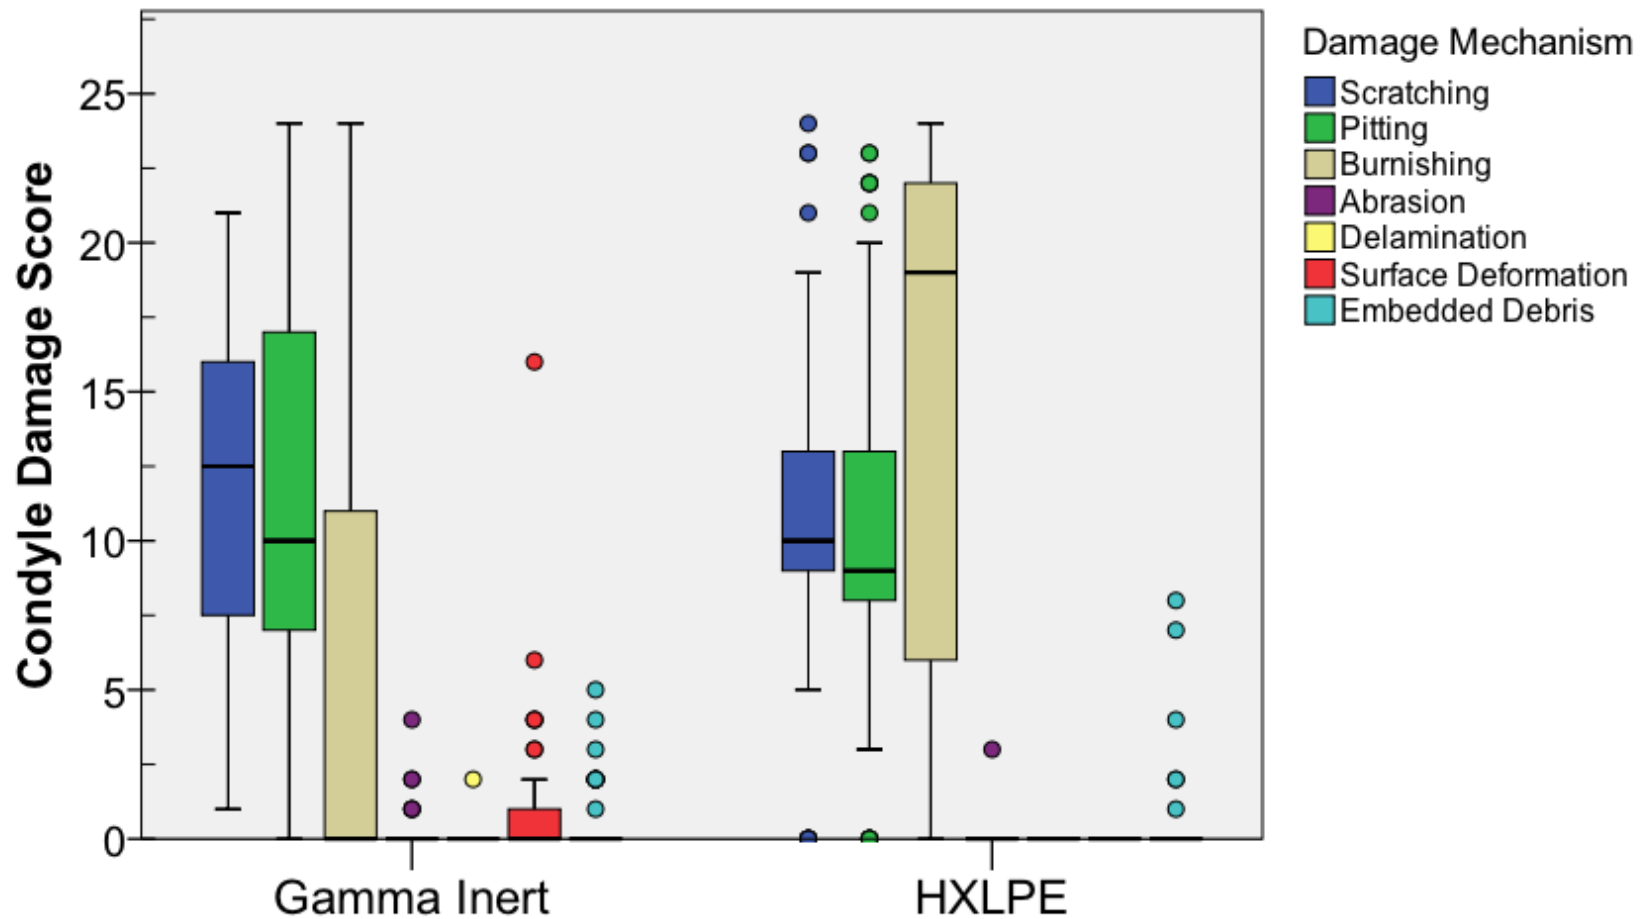
## Damage Scoring

- Pitting, Scratching and burnishing were the main damage modes
  - No delamination in HXLPE Cohort
  - 1 Case of Delamination in the gamma inert cohort
- Longer-term studies necessary to determine stability of remelted HXLPE in total knee replacement

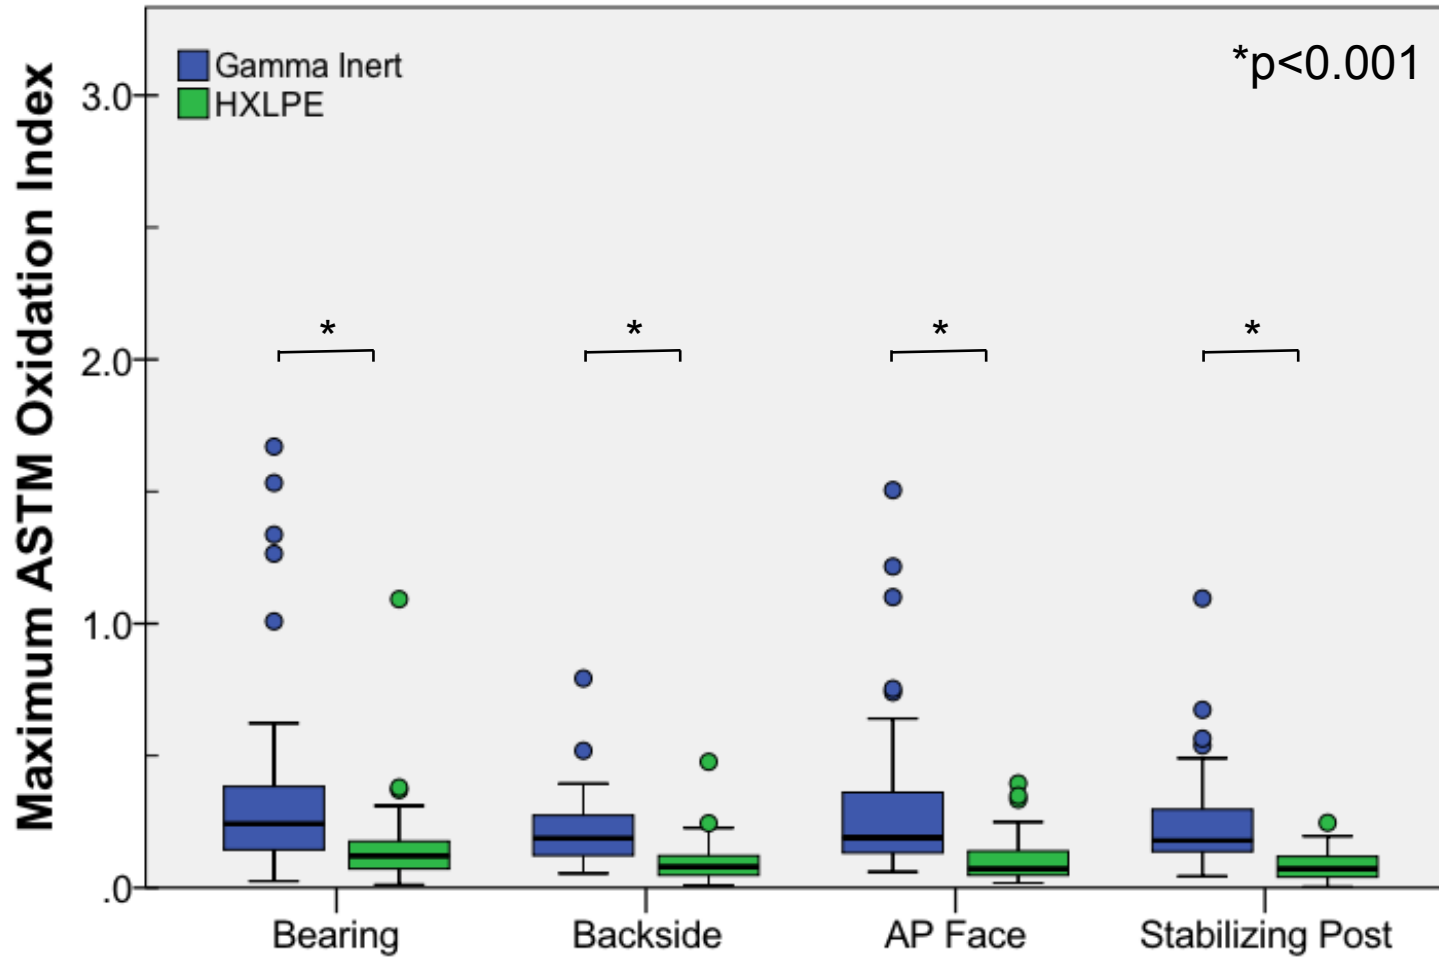
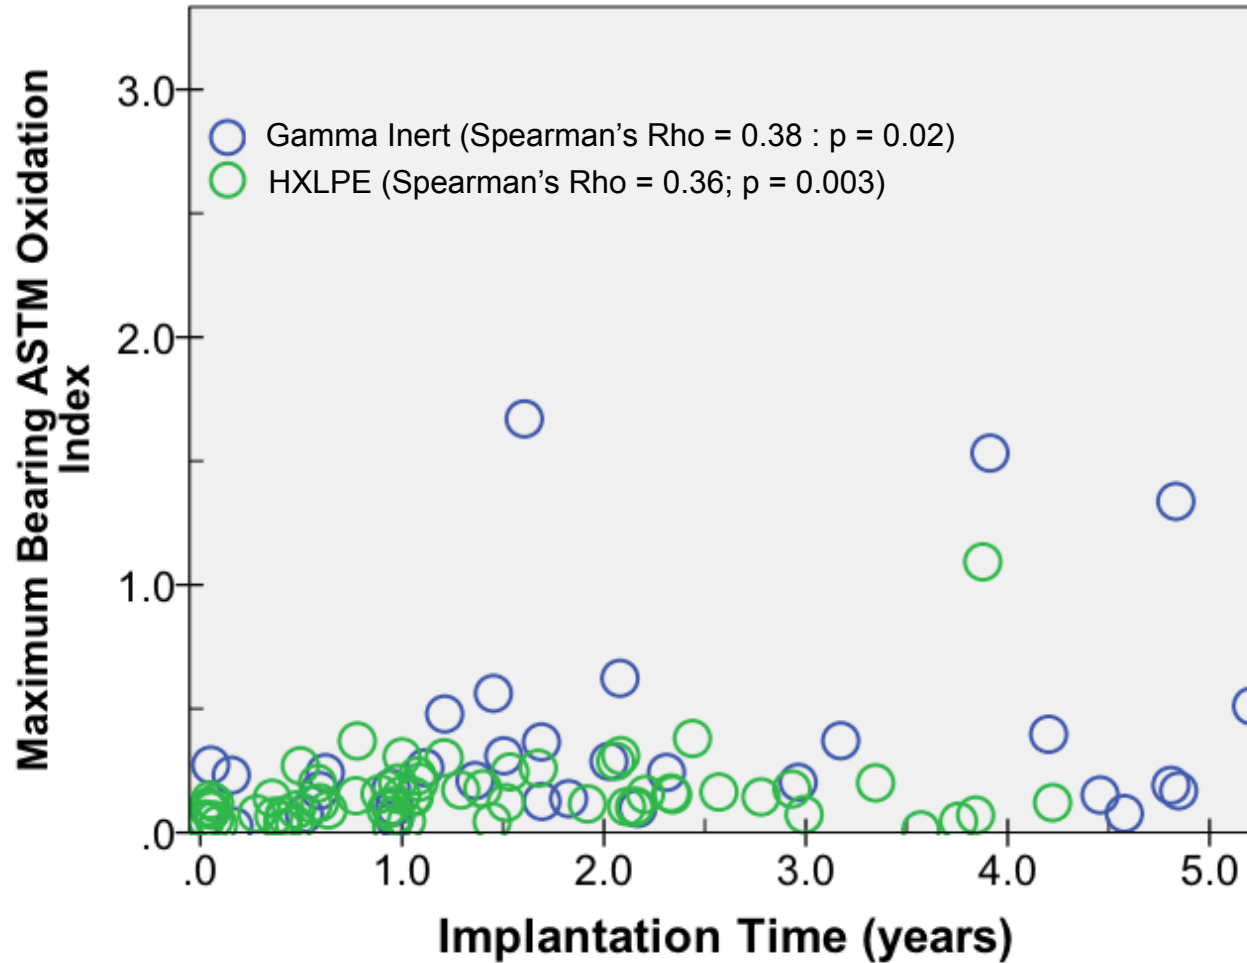
## Oxidation

- Remelted HXLPE exhibited lower oxidation levels than gamma inert implants.
- In gamma inert components, AP Face and Bearing Surface had the highest oxidation.
- In HXLPE components, the bearing surface had the highest oxidation.

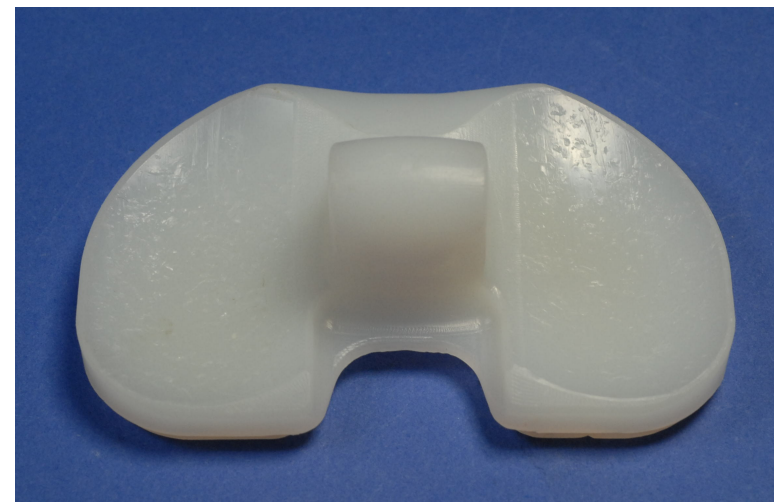
# Case Study #1

- 62 year old male
  - BMI: 30.3 kg/m<sup>2</sup>
- Implanted: 2005
  - Osteoarthritis
- Explanted: 2010
  - Tibial Loosening
  - UCLA<sub>Max</sub>: 5
- Low Oxidation (<0.3)
- Pitting, scratching, and Burnishing

*in vivo*: 4.2 years

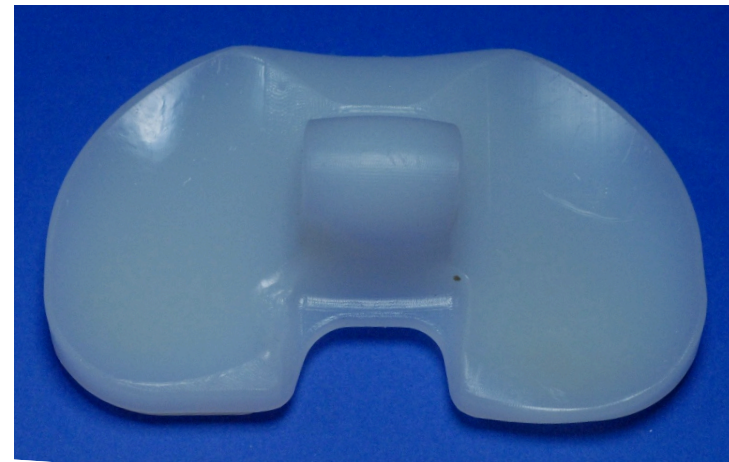
# Case Study #2

- 48 year old male
  - BMI: 28.4 kg/m<sup>2</sup>
- Implanted: 2005
  - Osteoarthritis
- Explanted: 2009
  - Tibial Loosening
  - UCLA<sub>Max</sub>: 10
- Moderate Oxidation (1.1 at the bearing surface)
- Pitting, scratching, and Burnishing

*in vivo*: 3.9 years
