Tradeoffs in Crosslinked UHMWPE used in Total Joint Arthroplasty

Lisa A. Pruitt, Ph.D.

Department of Mechanical Engineering and Bioengineering
U.C. Berkeley

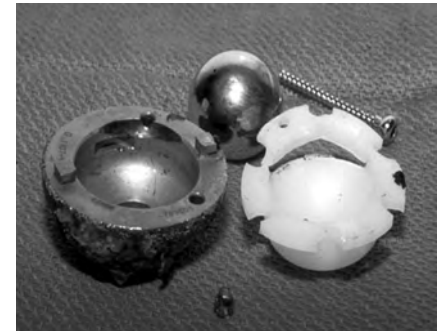
Clinical retrievals exhibiting fatigue fractures

Clinical fractures: initiated at sites of stress concentrations in crosslinked acetabular liners (4 manufacturers) ranging in crosslinking dose from 4-10 Mrad. No oxidation was detected (OI = 0.072 – 0.1). Time *in-vivo* : 3 mo - 5.5 yrs.

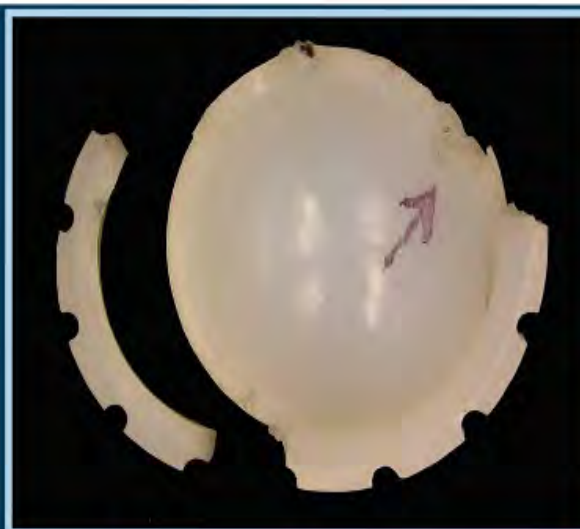
Figure 2.

Top view of explanted liner and part of fractured rim.

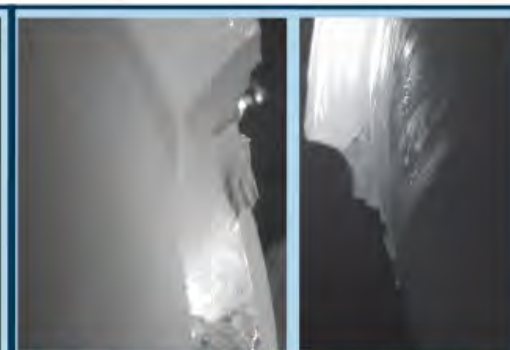
Figure 3.

Detail view of vertical slot crack initiation. Cracks curve down into the primary fracture plane

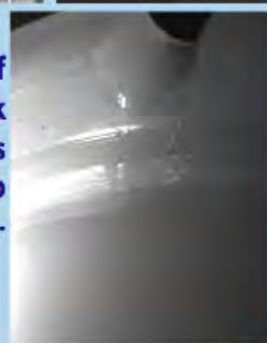
Figure 4.

Primary crack surface is non-planar and joins adjacent vertical slots. Striations spread from the peak, implying initiation at the now absent vertical slot.

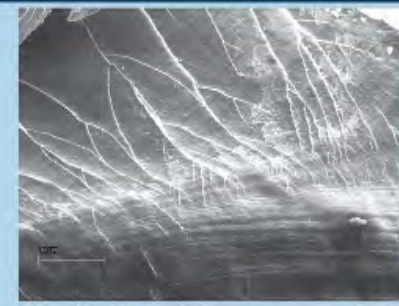
Border of tearing and faceting propagation on extreme surface.

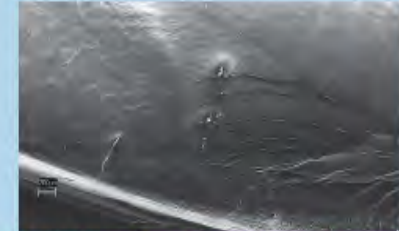
Detail showing transitions from initiation striations to include a tearing mode. Upper portion does not show as much tearing.

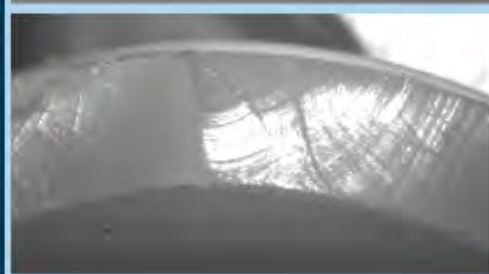
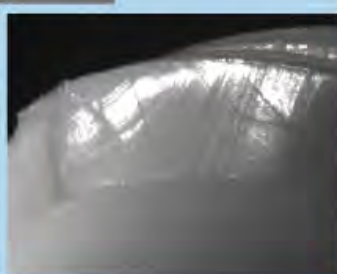
Liner Locking Mechanism Failure of a Crosslinked Acetabular Liner Caused by Impingement

A 65 year-old male (240 lbs., BMI = 30) underwent right total hip arthroplasty in 2002 for osteoarthritis.

Implants were an S-ROM femoral stem, 28mm+3 CoCr femoral head, 58mm Pinnacle shell, and 5 Mrad Marathon XLPE liner (Depuy, Warsaw, IN).

5 of the 6 liner locking tabs fractured.

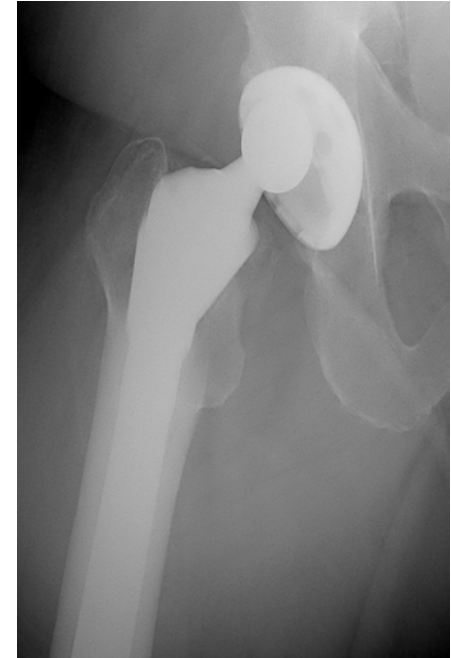
Radiographs demonstrated eccentric position of the femoral head within the acetabular shell consistent with dissociation of the liner.

Revision total hip arthroplasty was performed during which displacement of the liner from the acetabular shell was confirmed
