Thesis or Dissertation Title: Investigation of Modular Taper Material and Design Factors That Affect Mechanically-Assisted Crevice Corrosion at the Femoral Head-Stem Interfaces in Total Hip Arthroplasty

Author's Name: Sevi Berna Kocagoz

Month and Year: June 2020

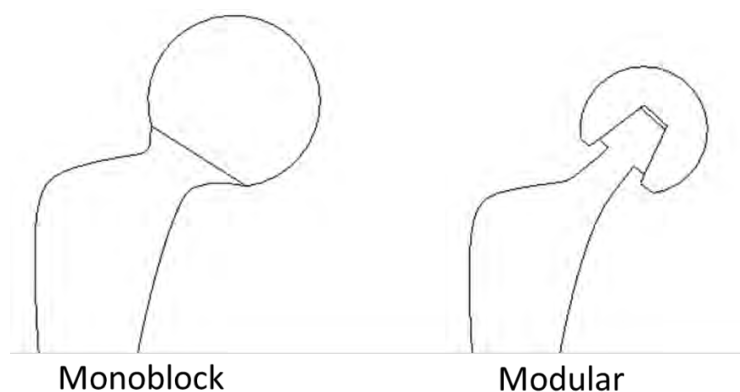
Figure 1: Monoblock hip joint replacement with femoral head fixed to the femoral stem. Modular hip joint replacement with removable and interchangeable femoral head and stem.

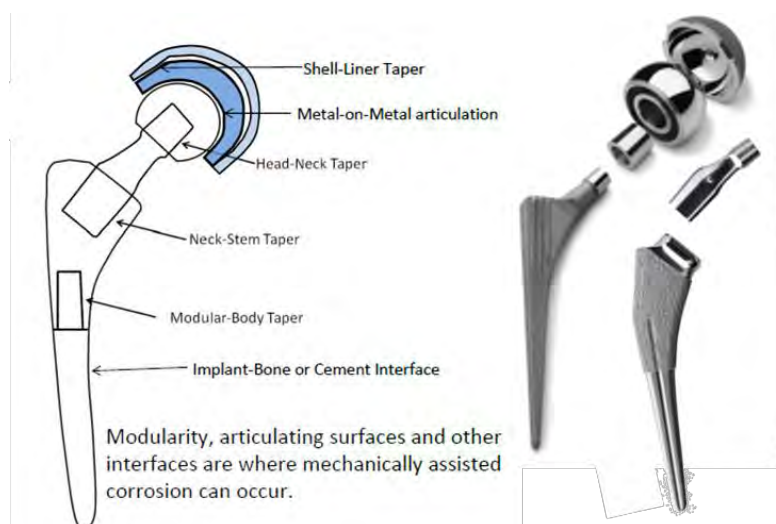
Figure 2: Schematic of *possible* locations of modularity and commercially available examples. Modularity is available at the shell-liner, head-neck, neck-stem, modular-body tapers in total hip arthroplasty designs where MACC may occur. MACC may also occur at Metal-on-Metal articulating surfaces and implant-bone or cement interfaces [6, 109].

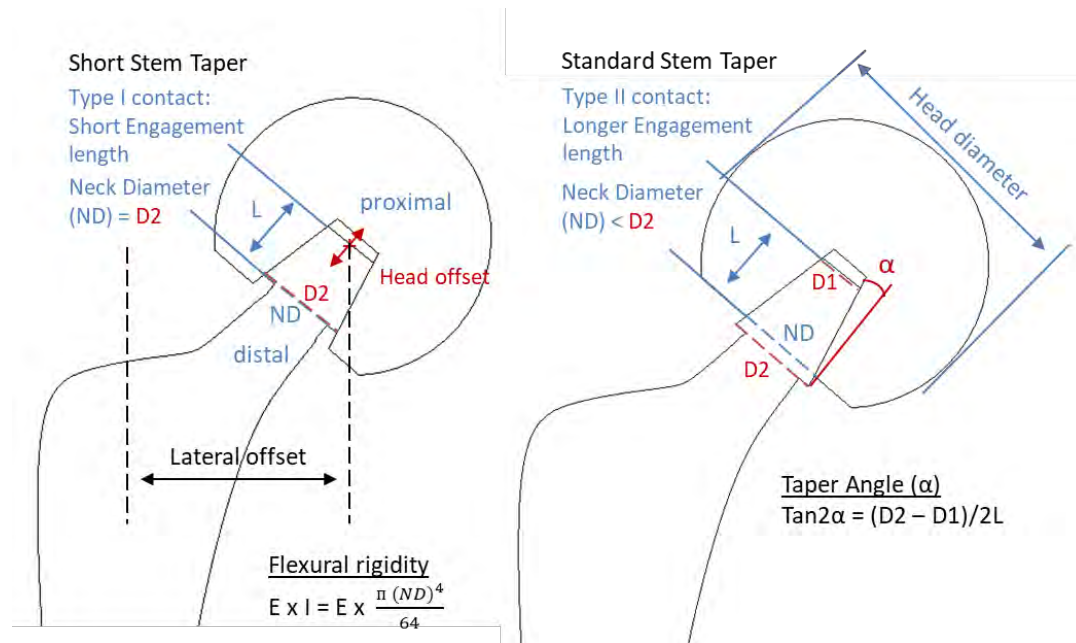
Figure 3: Figure showing some device design factors that affects the biomechanics of the head-stem modular taper.

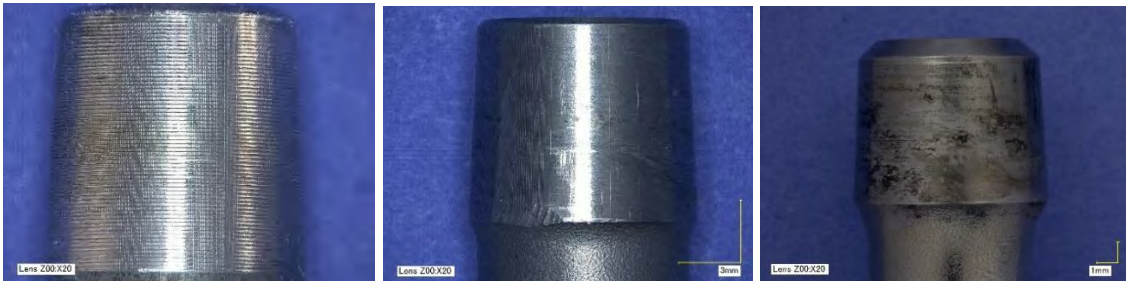
Figure 6: Figure showing 3 different examples of retrieval stem tapers, photographed at the same scale to show the difference of available stem taper size and surface finish.

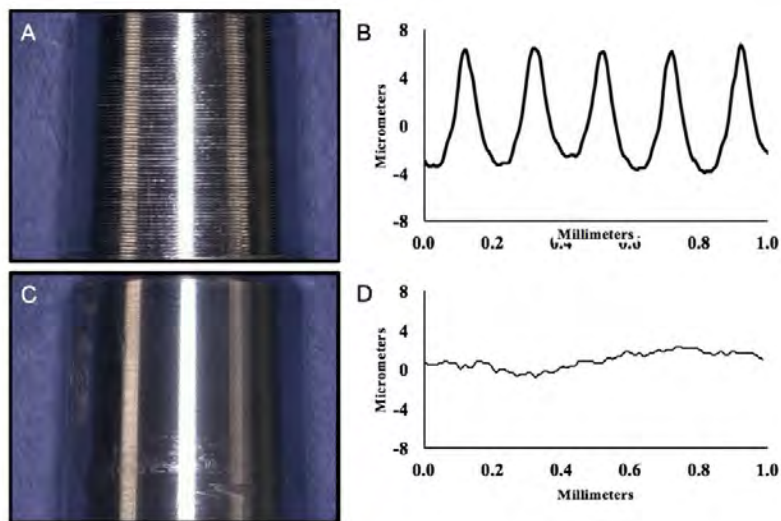
Figure 8: An example each of a micro-grooved and smooth stem taper. The figure is showing the photo of a micro-grooved stem (A) and corresponding surface profile with a typical grooved topography (B). The bottom row is showing a photo of representative smooth stem taper (C) and corresponding surface profile with a typical smooth topography (D) [7].

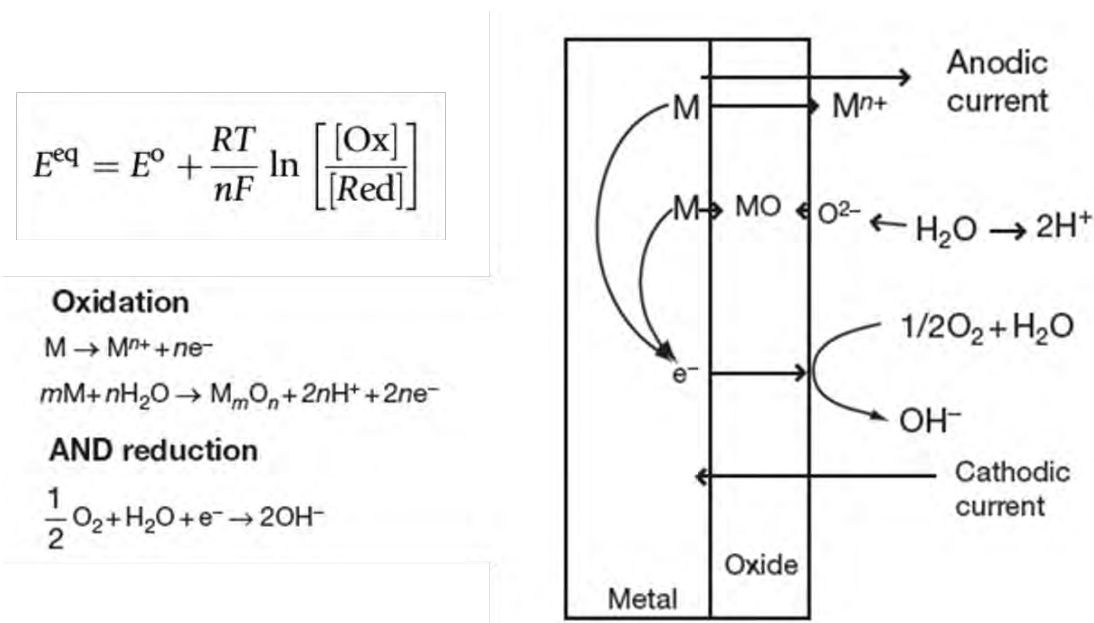
Figure 10: The equilibrium oxidation and reduction reactions taking place at the surface of a metal. Ion dissolution and anodic and cathodic currents are generated during the formation of the protective oxide film [84].

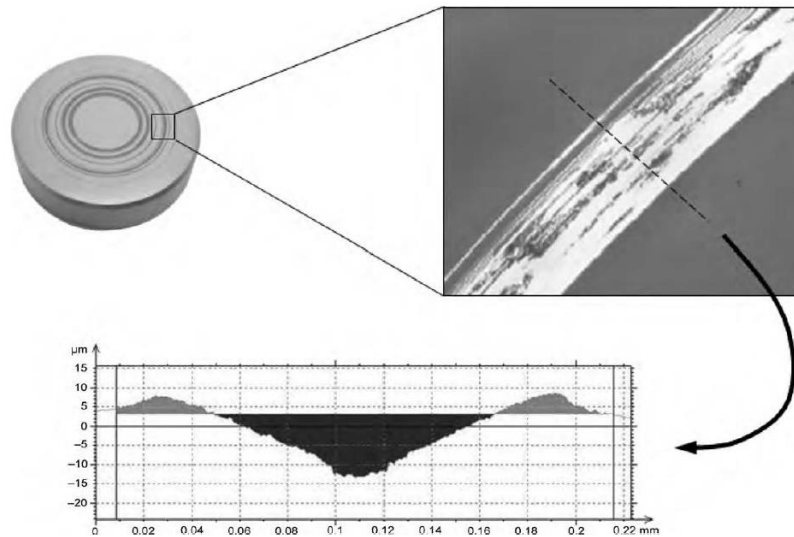
Figure 12: Wear scar section on stationary disk measured using stylus profilometer [207].

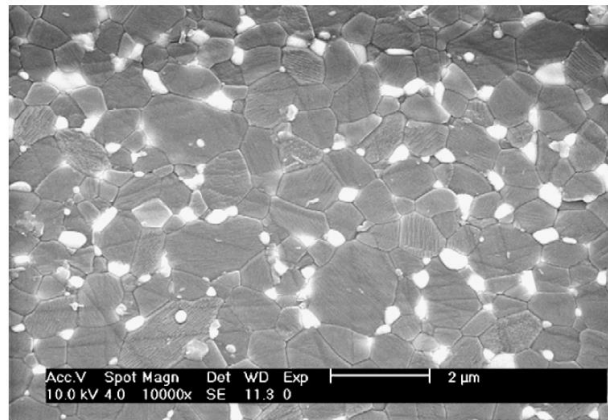
Figure 15: Scanning electron microscopy image of ZTA composite after polishing and thermal etching the surface. Alumina grains are the larger grains in grey and zirconia grains are smaller and white [210].

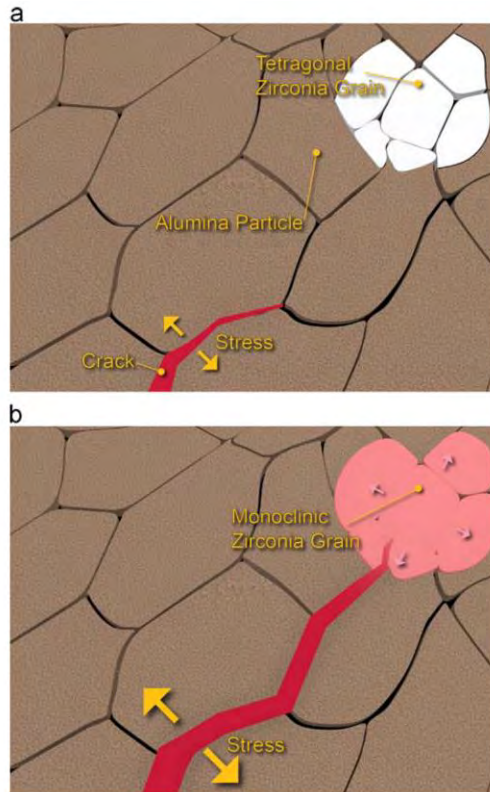
Figure 16: Crack propagation in a ZTA ceramic progressing at the alumina grain boundaries (a) and halting at the zirconia region (white – tetragonal phase) due to stress induced phase transformation and increased zirconia grain volume (red – monoclinic) (b).

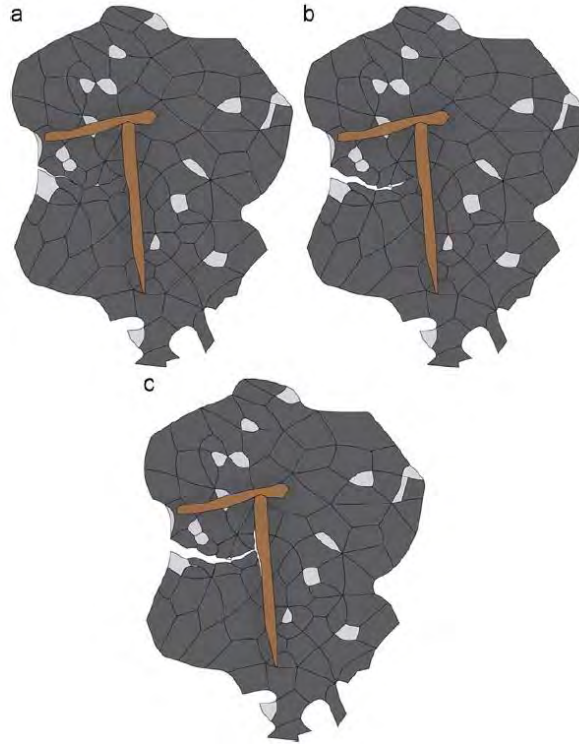
Figure 17: Crack propagation and halting in a ZTA ceramic with strontium aluminate (gold) and tetragonal zirconia (white) reinforcing particles present among the dark grey alumina grains.

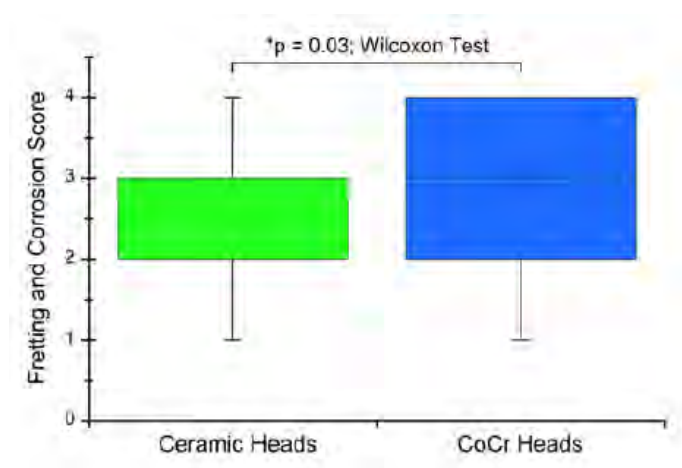
Figure 19: The femoral stem taper fretting and corrosion damage scores for the matched ceramic and CoCr head cohorts are shown. The damage scores were significantly lower for the ceramic cohort ($p = 0.03$).

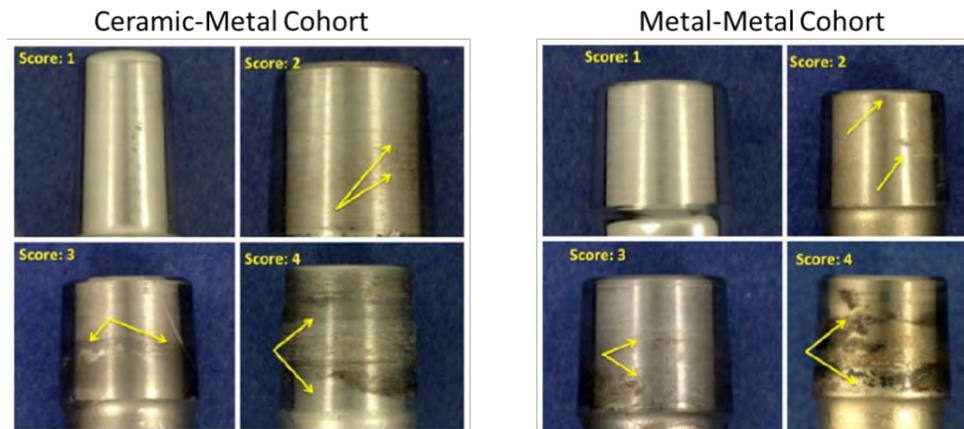
Figure 20: Some examples of stem taper fretting and corrosion scores for the ceramic-metal cohort (median score 2) and metal-metal cohort (median score 3).

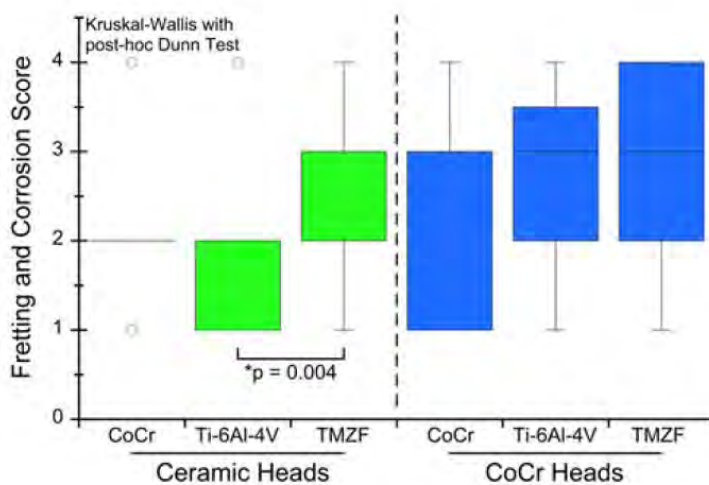
Figure 21: A boxplot illustrating femoral stem taper fretting and corrosion score versus stem alloy for the ceramic and metal head cohorts is presented.

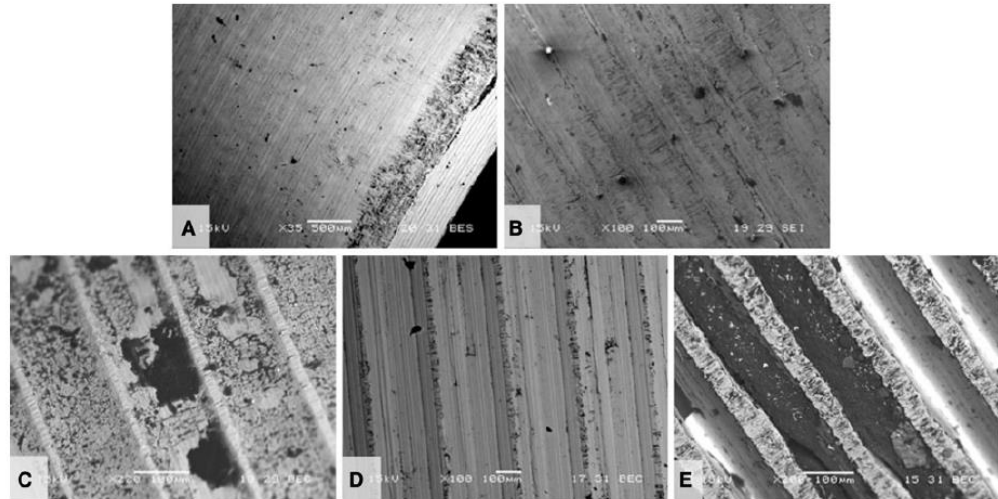
Figure 22: SEM images of five different design and materials for the stem tapers implanted with ceramic heads (A) TMZF (Stryker Orthopedics, Mahwah, NJ, USA) 9 35 BEC, (B) Ti-6Al-4V (Zimmer, Inc, Warsaw, IN, USA) 9 100 SEI, (C) Ti-6Al-4V (Wright Medical Technology, Inc, Arlington, TN, USA) 9 220 BEC, (D) Co-Cr-Mo (DePuy Orthopedics, Inc, Warsaw, IN, USA) 9 100 BEC, (E) Co-Ni-Cr-Mo (Zimmer) 9 100 BEC. SEI = secondary electron imaging; BEC = backscattered electron contrast image. A is a ground surface, whereas B–E have machining grooves present. Also shown are fretting scars and corrosion and biological debris present. For grooved implants, only the groove tips show evidence of fretting corrosion damage.

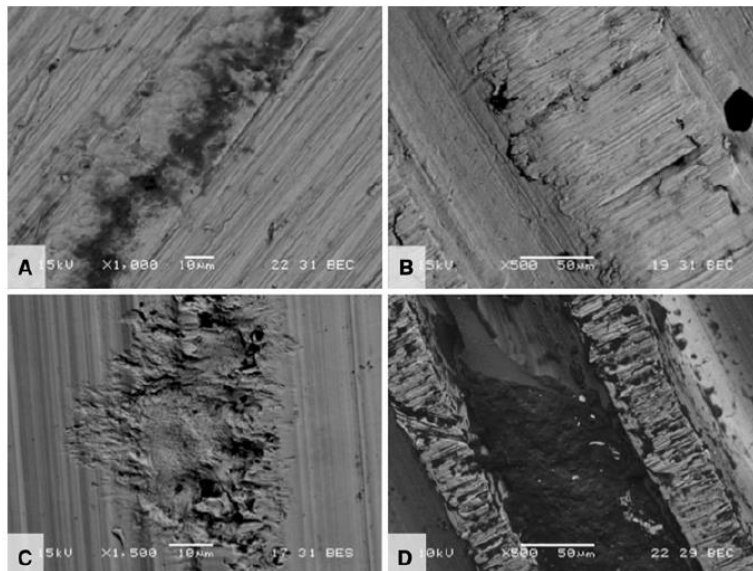
Figure 23: Backscattered electron micrographs of (A) TMZF, (B) Ti-6Al-4V, (C) Co-Cr-Mo, and (D) CoNiCrMo alloy tapers used in conjunction with ceramic femoral heads. Backscattered evaluation makes corrosion deposits appear black and help identify fretting damage and some corrosion debris present. In C, the damage has a distinctly corrosion-like appearance emanating from a machining ridge.

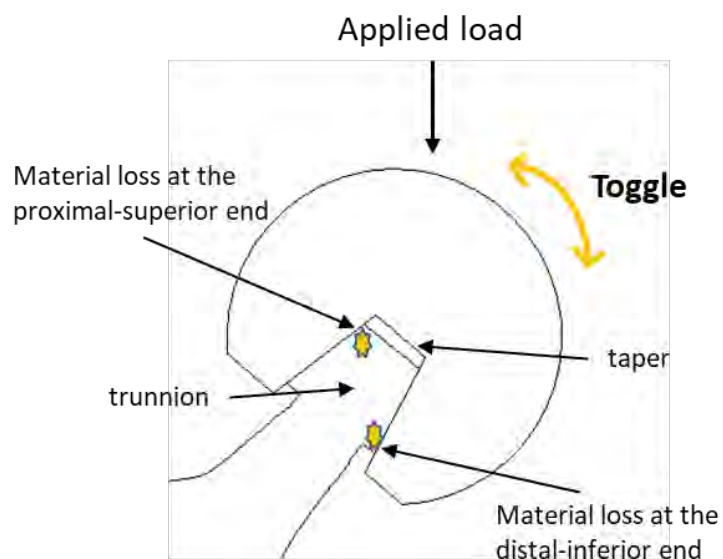
Figure 24: Illustration of hypothesized toggling mechanism of the femoral head due to applied cyclic loading and mismatched stem taper. Asymmetric damage mode may be seen in proximal-superior and distal-inferior regions.

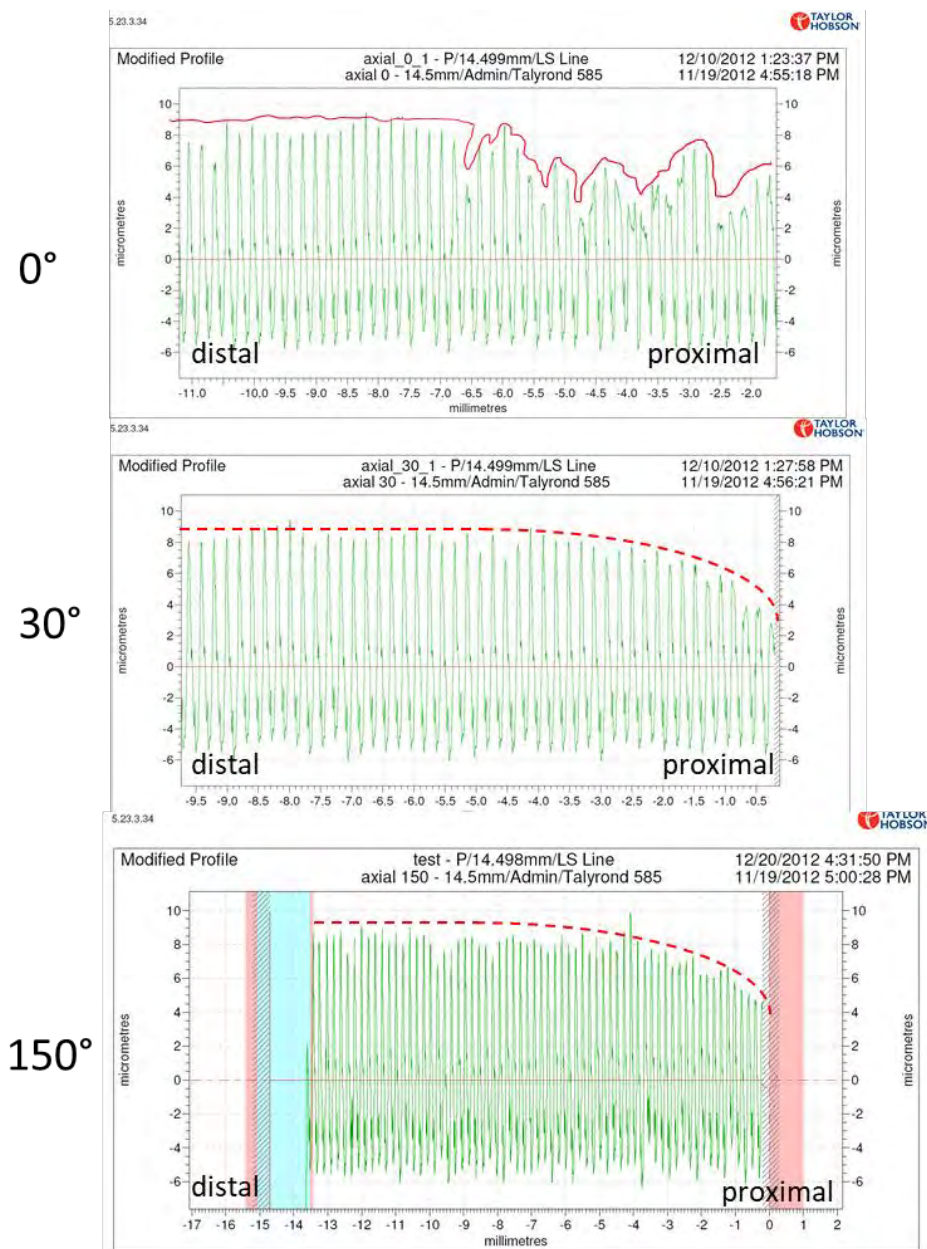
Figure 32: Stem taper axial profiles taken from the same stem at different locations 360° around the circular axis. The profile taken at 0° shows irregular changes in the profile which has been determined to be material loss due. For the profiles taken at 30° and 150°, the change in the profile seen in the proximal end is an example of change of form during implantation due to stem taper proximal end getting fitted into the head taper and getting compressed in the proximal region.

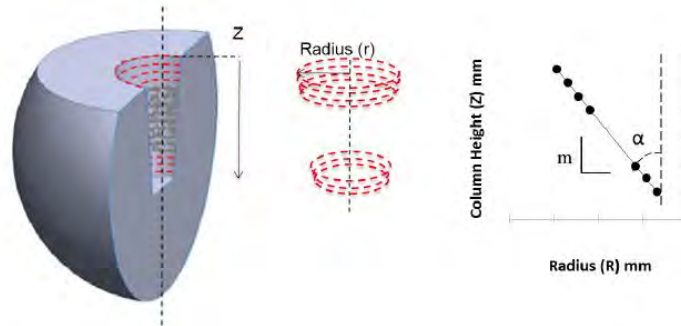
Figure 34: The radius and relative height of each LS circle was compiled in a spreadsheet and the linear slope of the 5-7 profiles were used to calculate the angle. Areas with corrosion debris were excluded from the measurements. Measurements were only taken in as-manufactured surfaces.

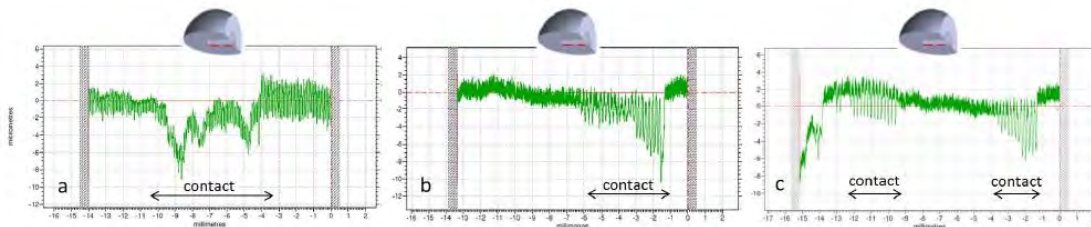
Figure 35: Examples of Talyrond traces for components with observable regions of material loss proximally (a), distally (b) and in both proximal and distal locations (c). The red lines on the schematic of the femoral heads represent the orientation of the profiles being measured. These profiles provide information about the taper-trunnion junction in addition to the clearance values observed for the metal cohort.

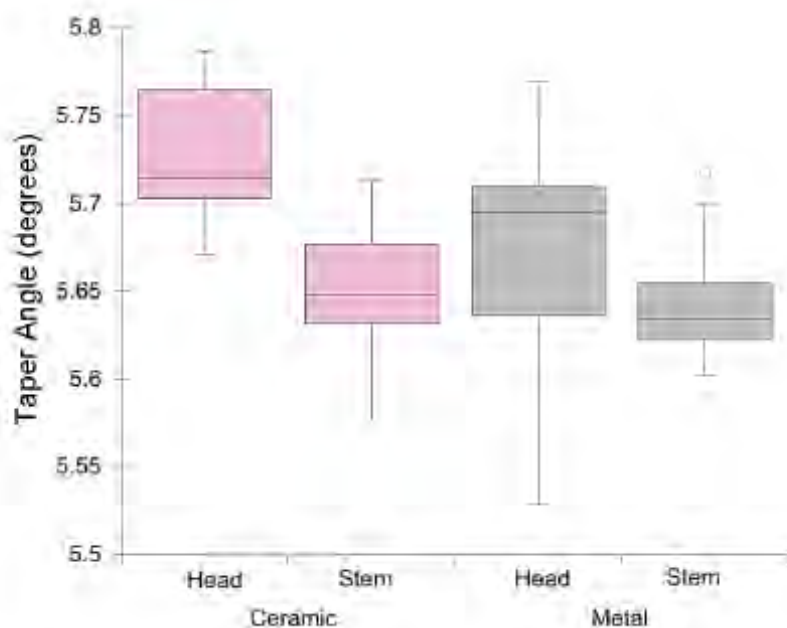
Figure 37: Taper angle measurements for the ceramic and metal head-stem pairs. There is no overlap in the taper and trunnion angle measurements for the ceramic cohort, while there is overlap in the metal cohort.

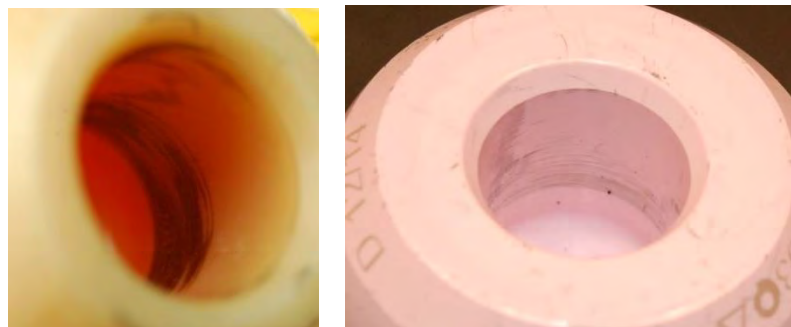
Figure 39: Metal transfer was observed on the proximal ends of the internal tapers of ceramic heads, providing visual confirmation for clearance values greater than zero for the ceramic cohort.

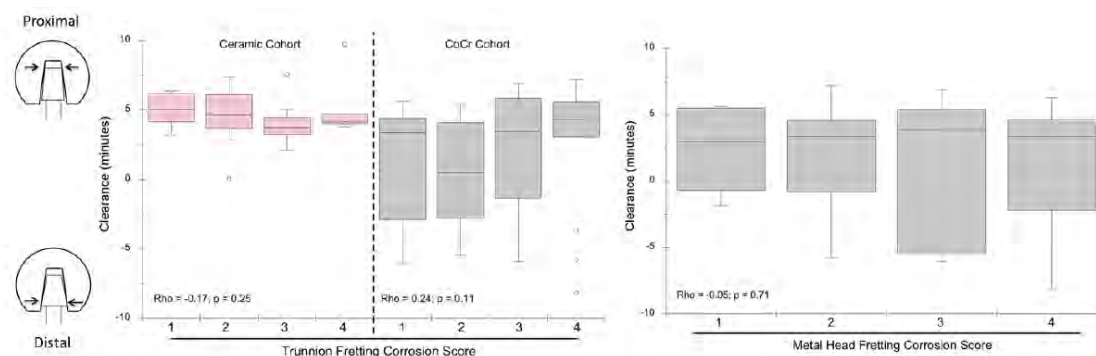
Figure 40: Distribution of measured ceramic and metal cohorts according to a) trunnion fretting corrosion score, and metal cohort according to b) metal head fretting corrosion score.

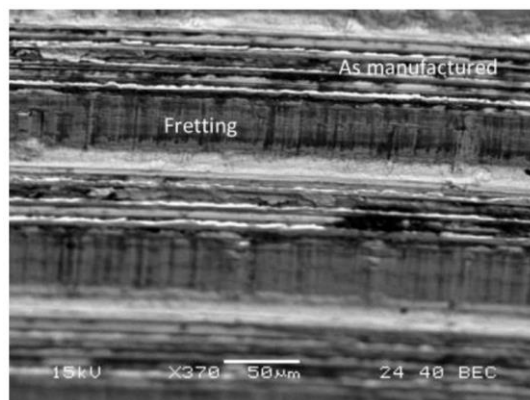
Figure 41: SEM image taken in distal portion of metal head taper showing fretting in regions with horizontal bands of material loss. Bands of material loss most likely corresponded to regions in contact with trunnion as-manufactured grooves (370x, BEC).

Figure 85: Also Figure 41 from Chapter 3, SEM image taken in distal portion of metal head taper showing fretting in regions with horizontal bands of material loss. Bands of material loss most likely corresponded to regions in contact with trunnion as-manufactured grooves (370x, BEC).

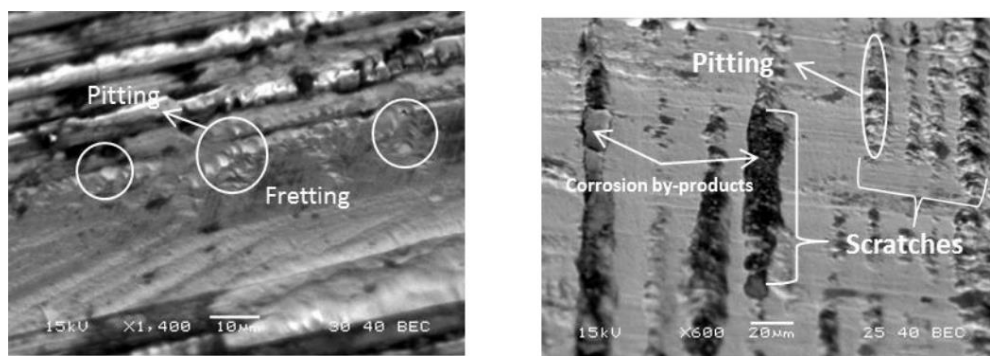
Figure 42: A component showing pitting corrosion (marked in white circles) initiated preferentially in a crevice formed due to fretting abrasion (5-40µm scratches), imaged midway between proximal and distal ends on the taper (left, BEC, 1400x). A different component showing scratches (50-500µm) throughout head taper, with preferential pitting inside the scratches, imaged midway between proximal and distal ends on the taper (right, BEC, 600x). Corrosion by-products (biological and electrochemical deposits) have accumulated inside the scratches.

Figure 86: Also Figure 42 from Chapter 3, a component showing pitting corrosion (marked in white circles) initiated preferentially in a crevice formed due to fretting abrasion (5-40µm scratches), imaged midway between proximal and distal ends on the

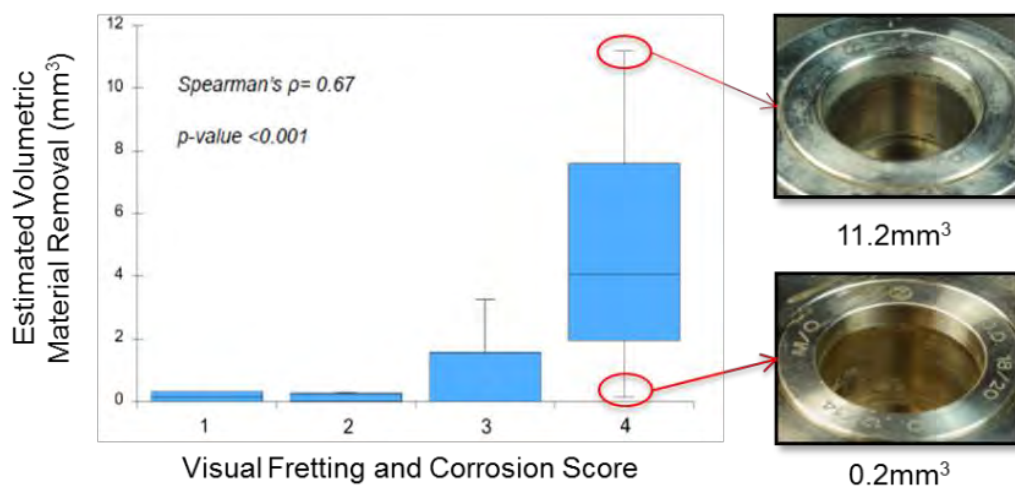
Figure 48: There is a large variability in the range of estimated volumetric material loss in components with severe (4) visual fretting-corrosion scores.

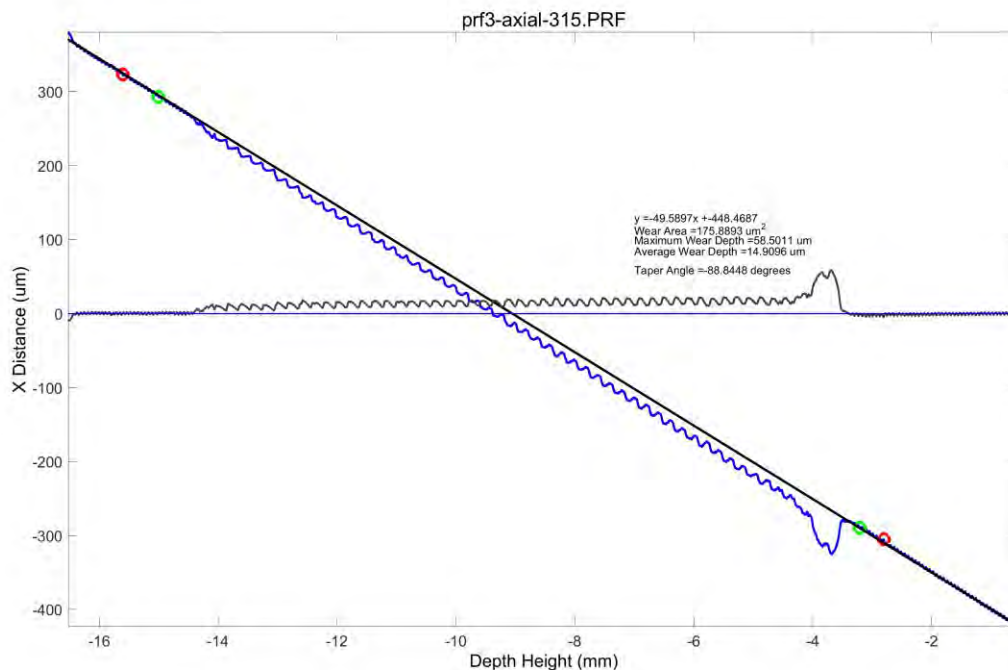
Figure 49: Example of an imported axial trace and analysis in custom MATLAB R2016a. The user is prompted to select limits on the proximal and distal ends to select region to exclude during least squares fitting to identified as-manufactured surfaces.

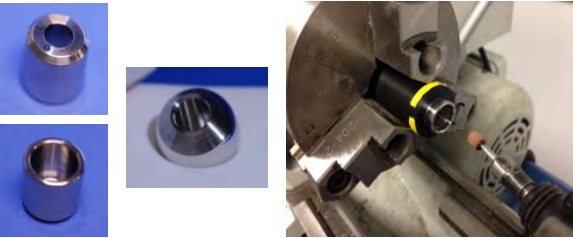
Table VII (continued):

<p>Method Development – Simulating Material Loss in Vitro</p>	<p>A quantitative method to estimate the severity of material loss in vitro was developed using surface profiles. Never implanted taper adapter sleeves and CoCr femoral heads were machined to simulate the same patterns and depth of material loss seen in retrievals.</p>

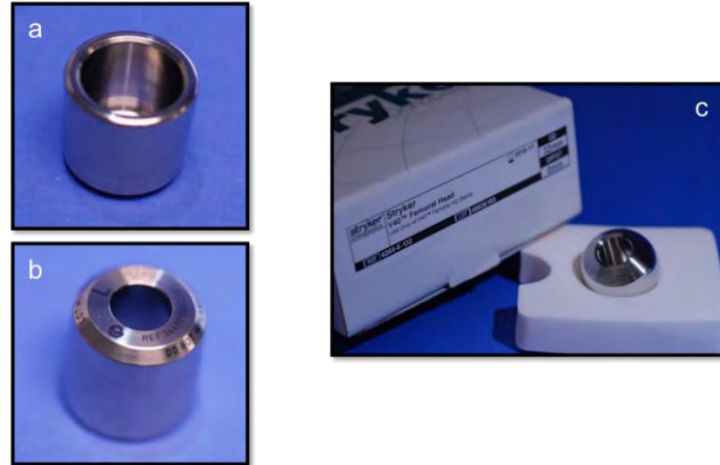
Figure 50: Exemplar taper adapter sleeves and femoral heads used for gravimetric validation.

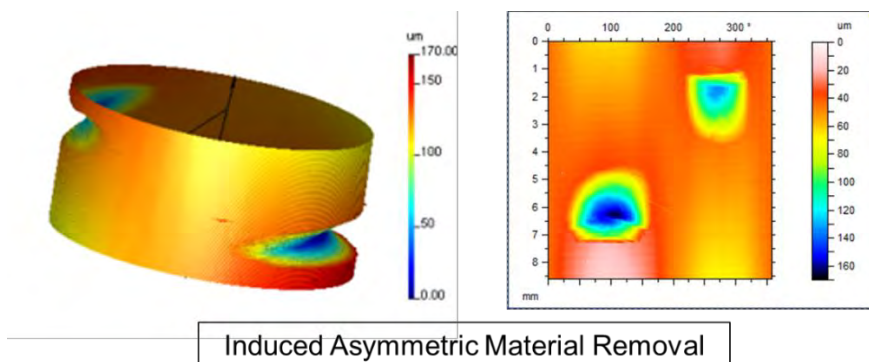
Figure 54: In vitro material removal using lathe and Dremel setup simulating asymmetric material loss. Asymmetric material loss is speculated to occur due to toggling.

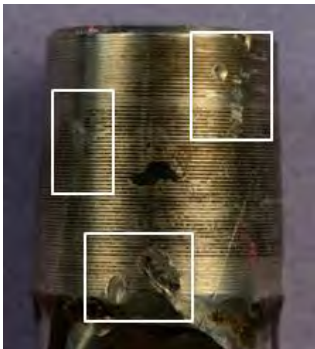
Table VIII: Method to quantify volumetric material loss from retrieval male taper surfaces with fretting-corrosion damage.

Step	Method	Figures
Identifying regions with iatrogenic damage	Male tapers have risk of getting iatrogenic damage during removal surgery (regions in white boxes). Iatrogenic damage needs to be identified and eliminated from material loss calculation.

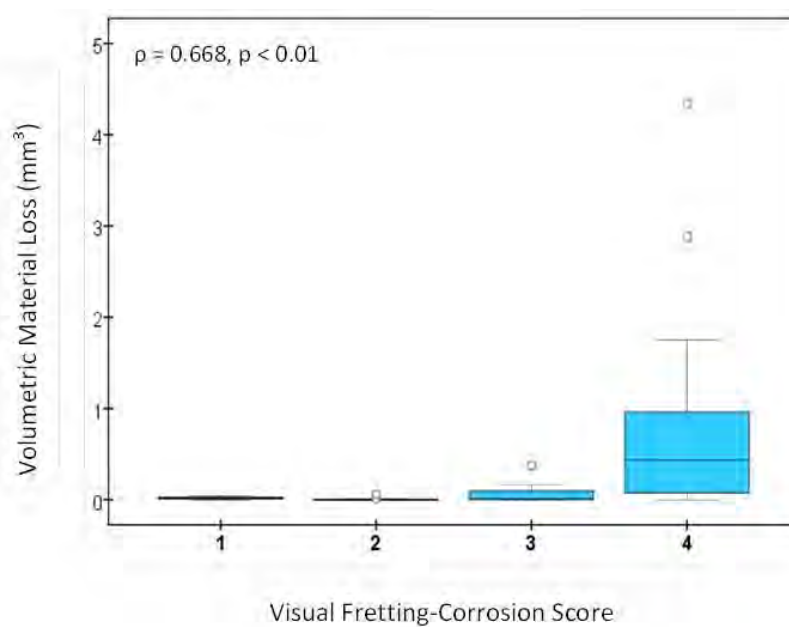
Figure 60: Correlation between visual fretting corrosion score and estimated volumetric material loss in the CoCr cohort.

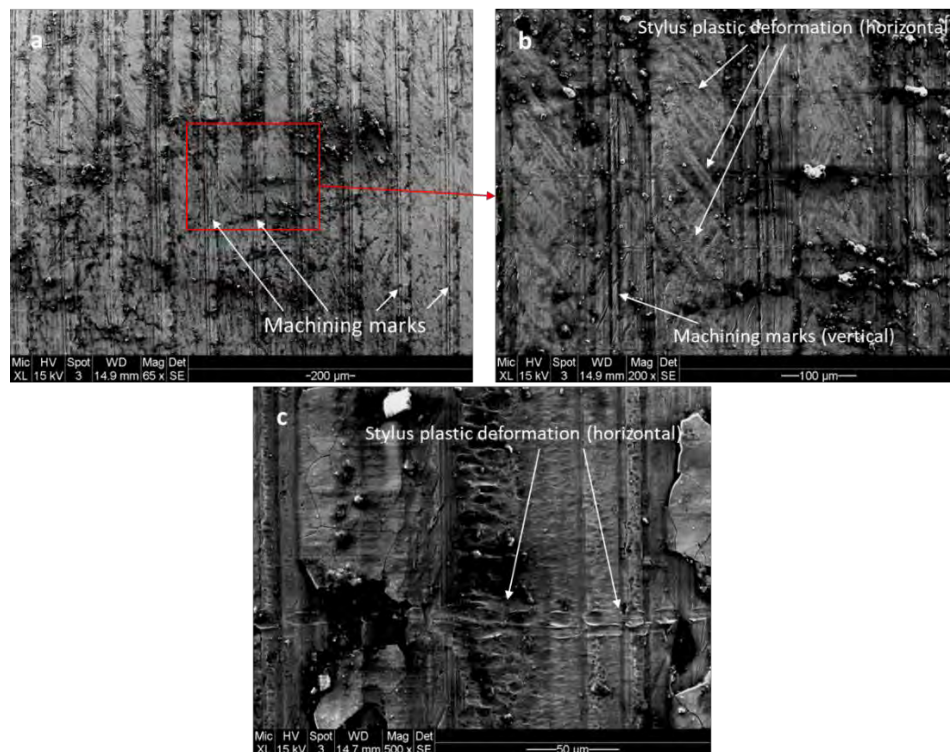
Figure 62: Stylus tip evidence of plastic deformation on the taper surface of one of our measured CoCrMo femoral heads. This deformation does not affect the results and the effects are negligible. The same area is shown with different magnifications to give an idea of the plastic deformation relative to the size of other features, a) mag 65x, showing machining marks, b) mag 200x, showing machining marks and stylus tip plastic deformation, c) mag 500x showing plastic deformation up close.

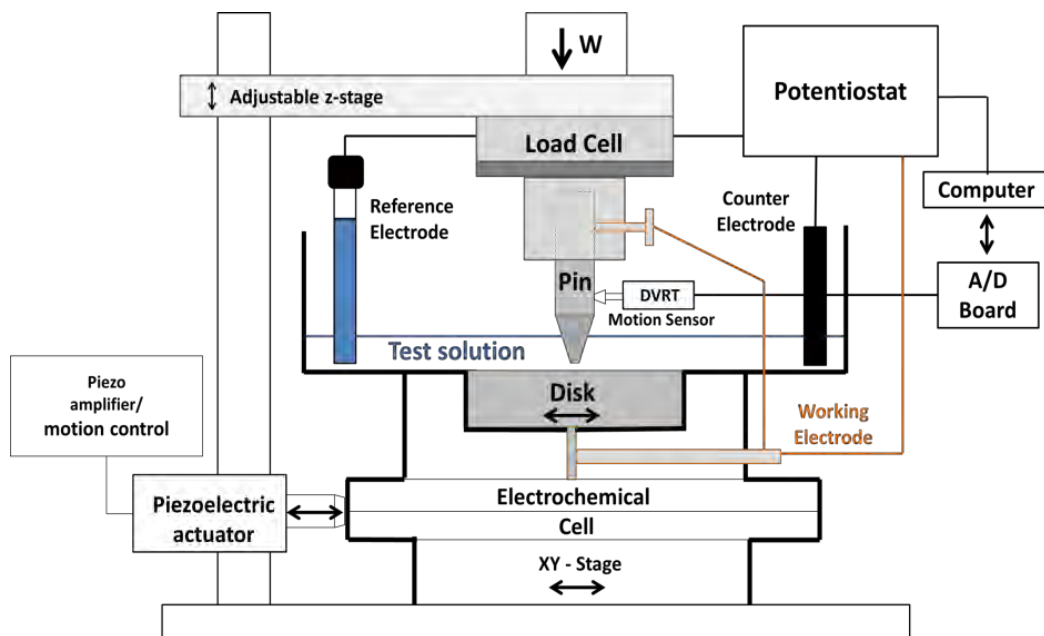
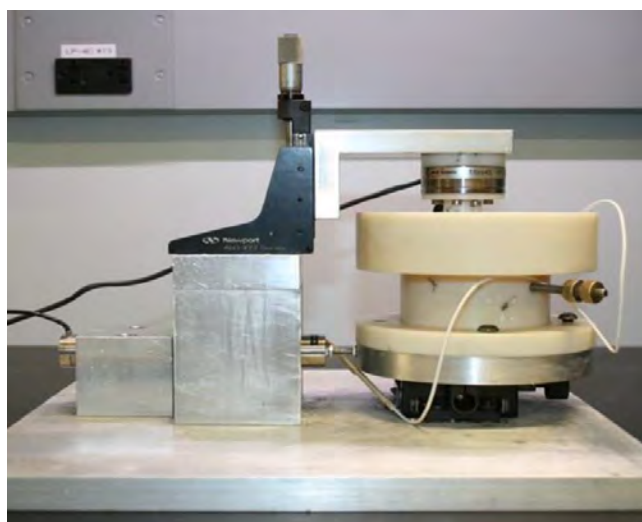
Figure 66: Previously published tribocorrosion test set-up schematic and photo [226]. Test solution PBS (pH 7.4). Fretting is simulated by the piezoelectric actuator. Motion of pin relative to disk is captured with the DVRT.

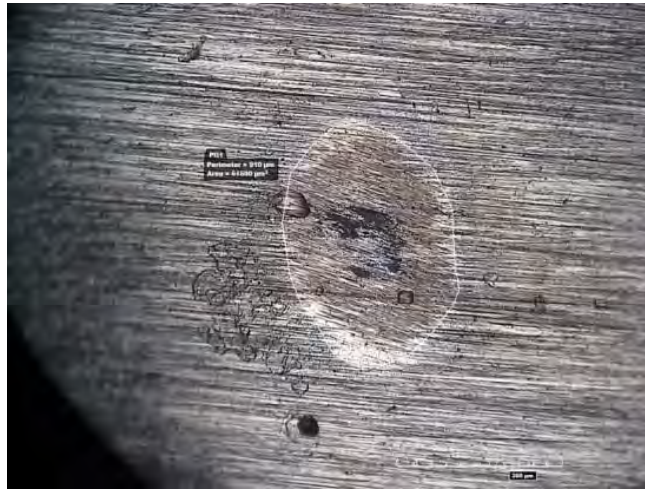
Figure 67: Pin tips and disks inspected using scanning electron microscopy (JEOL JSM-5600) and optical microscopy (KH-8700, HIROX) for quantification of contact area. Area calculation feature is available on the KH-8700 by selecting the worn area.

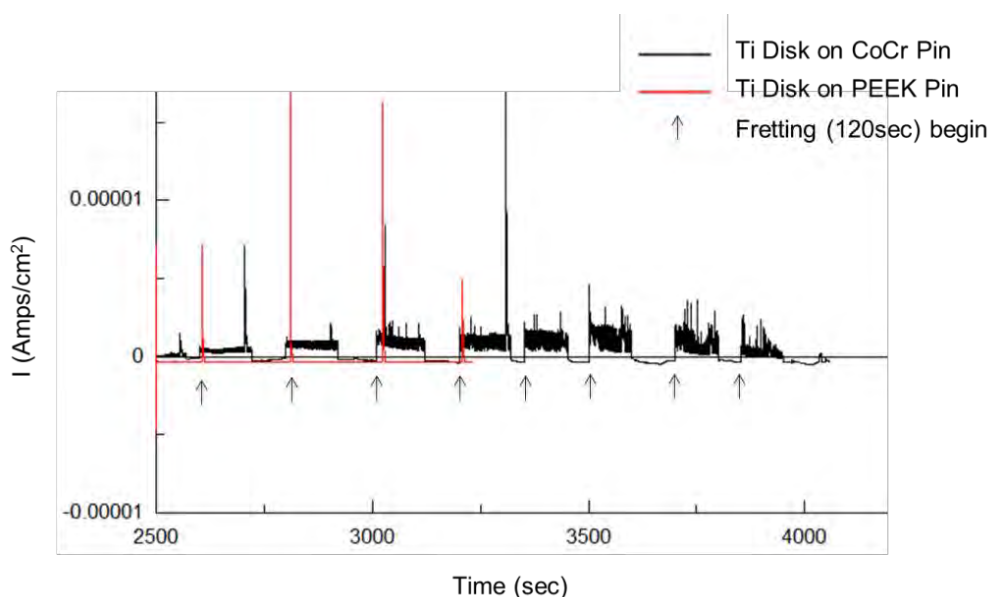
Figure 70: Fretting-current density ($I(\text{Amps}/\text{cm}^2)$) vs. time depicts the orders of magnitude difference in currents generated between the Ti/CoCr material couple (in black) and the Ti/PEEK couple. Arrows show fretting initiation. The spikes in fretting-current at the initiation of fretting (where the arrows are) and sometimes at the end of fretting are noise and were excluded from analysis.

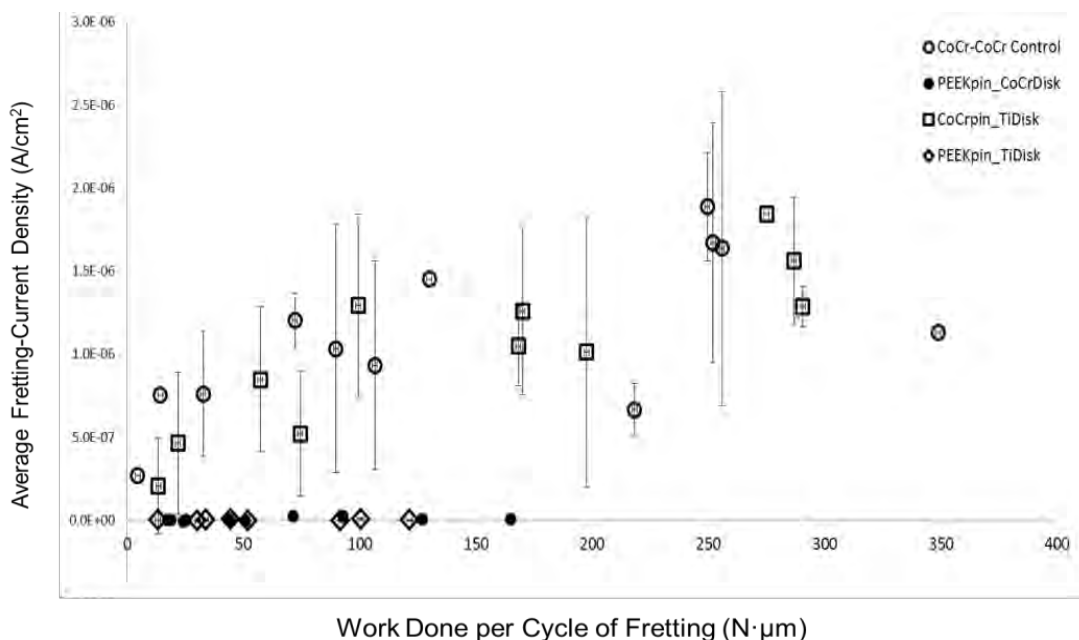
Figure 71: Average fretting current density vs. work done per cycle of fretting for all four material couples. Work done and average fretting current density is significantly higher for metal-metal couples compared to PEEK-metal. Average values obtained from triplicate tests for each material couple is compiled.

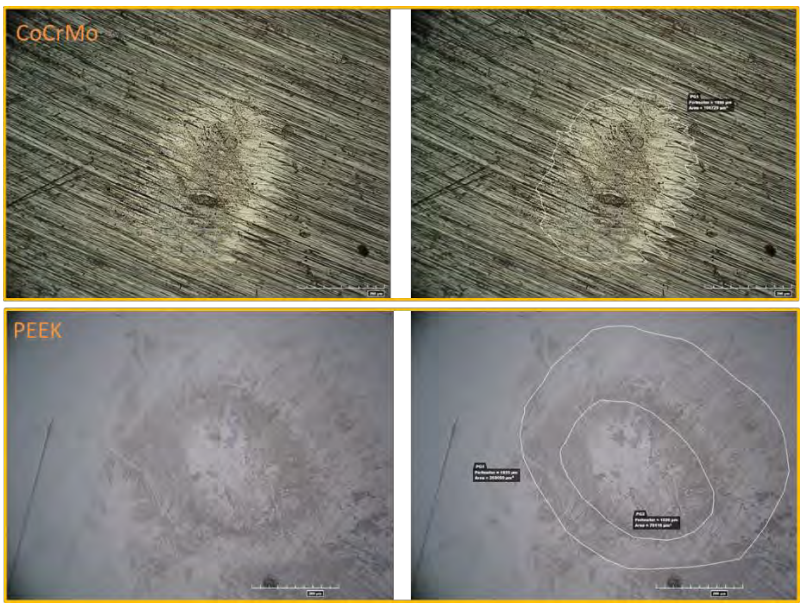
Figure 76: Example damage zones identified on the optical microscope (KH-8700, HIROX) for CoCrMo and PEEK post testing. Damage zones identified based on scratches in different appearance than machining marks. The surface area calculation feature on the microscope is used to find real contact area.

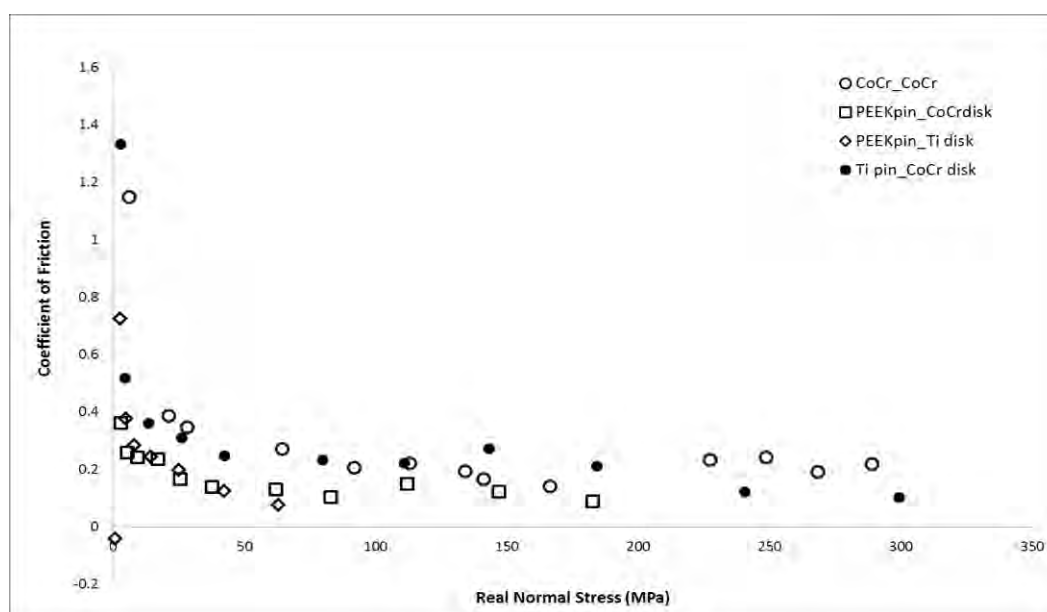
Figure 77: Coefficient of friction (COF) values vs. real normal stress for all material couples. Irrespective of material couple, COF values start higher and decreases quickly in a small range of applied stress and reaches a plateau value. Average values obtained from triplicate tests for each material couple is compiled.

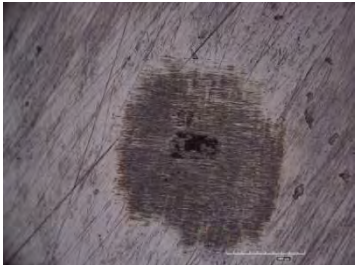
Material Couple (Disk/Pin)	Disk	Pin
CoCrMo/ CoCrMo

Table XII: Fretting-scars and other surface changes on the disks and pins post-testing.

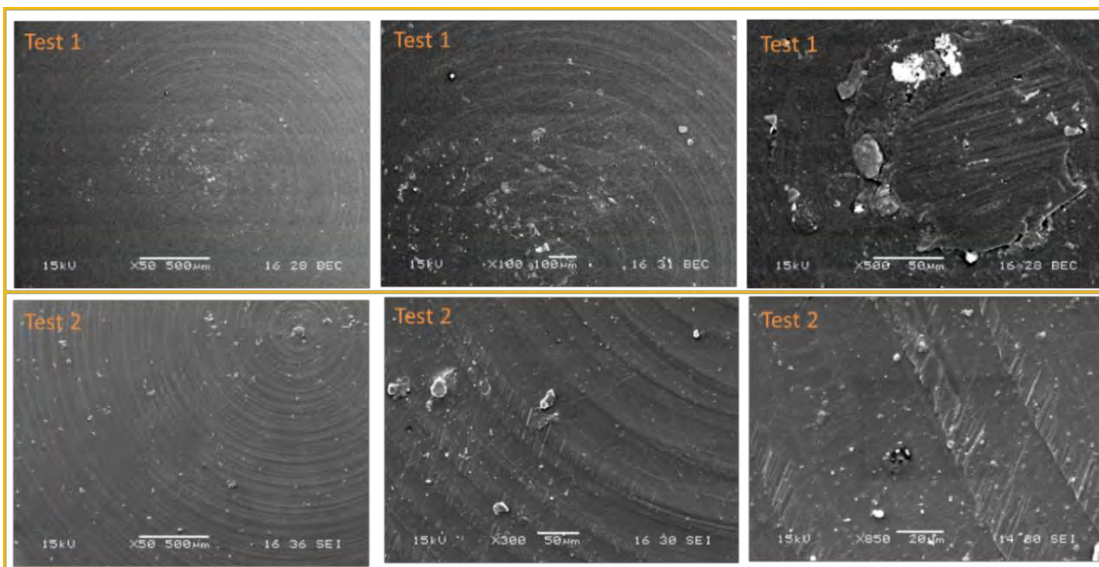
Figure 78: PEEK pellet SEM scratching seen after test 1 and test 2. Different pellets were used for each test. The images above are the same region with different magnification, focusing on the most damaged area.

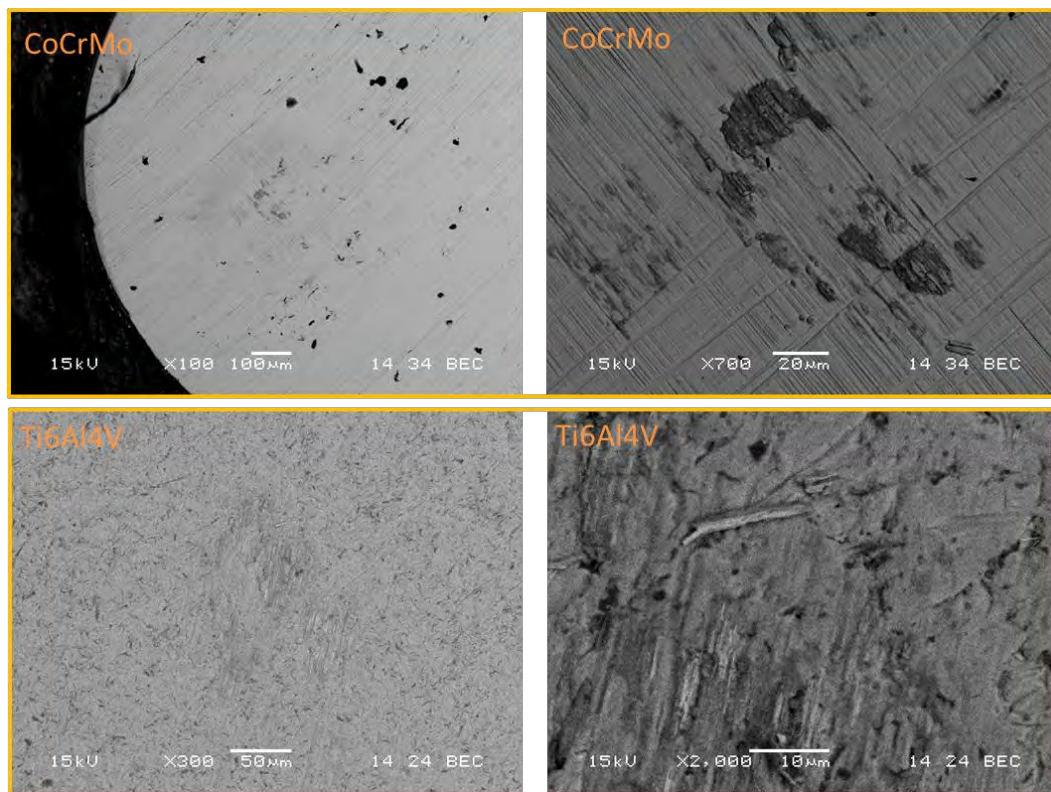
Figure 79: Representative surface scratching for CoCrMo post-test. Representative galling damage for Ti6Al4V post-test.

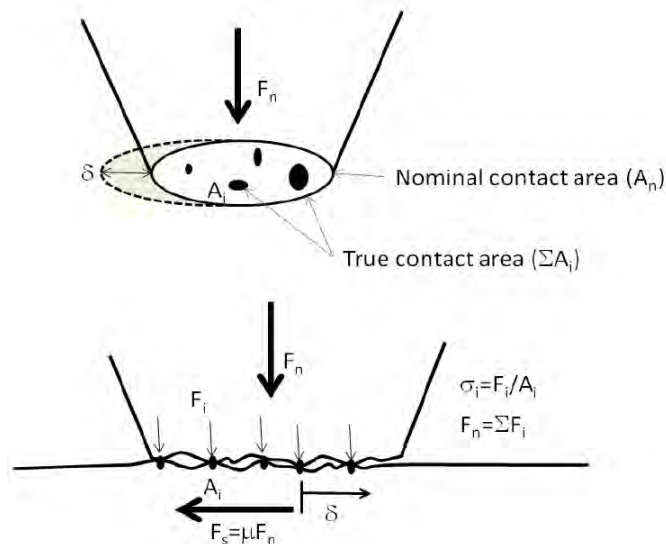
Figure 80: Discrepancy between the true asperity-asperity contact area and the nominal contact area. The nominal contact area is equal to the area of the observed fretting-wear scar post-testing [225].

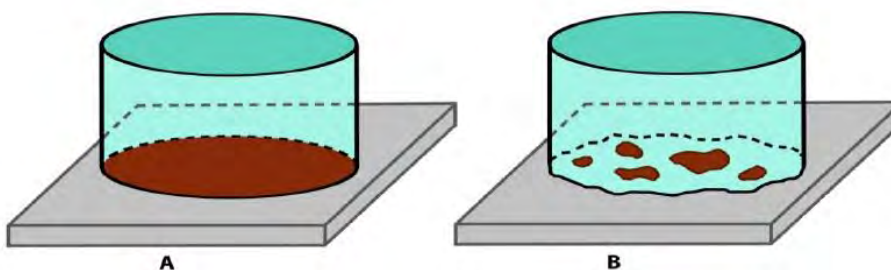
Figure 81: Schematic representation of the pin on disk contact of the pin tip and disk. A) ideal smooth, nominal contact is in brown. B) real asperity-asperity contact area in brown.
