Thesis or Dissertation Title: Investigation of Modular Taper Material and Design Factors That Affect Mechanically-Assisted Crevice Corrosion at the Femoral Head-Stem Interfaces in Total Hip Arthroplasty

Author's Name: Sevi Berna Kocagoz

Month and Year: June 2020

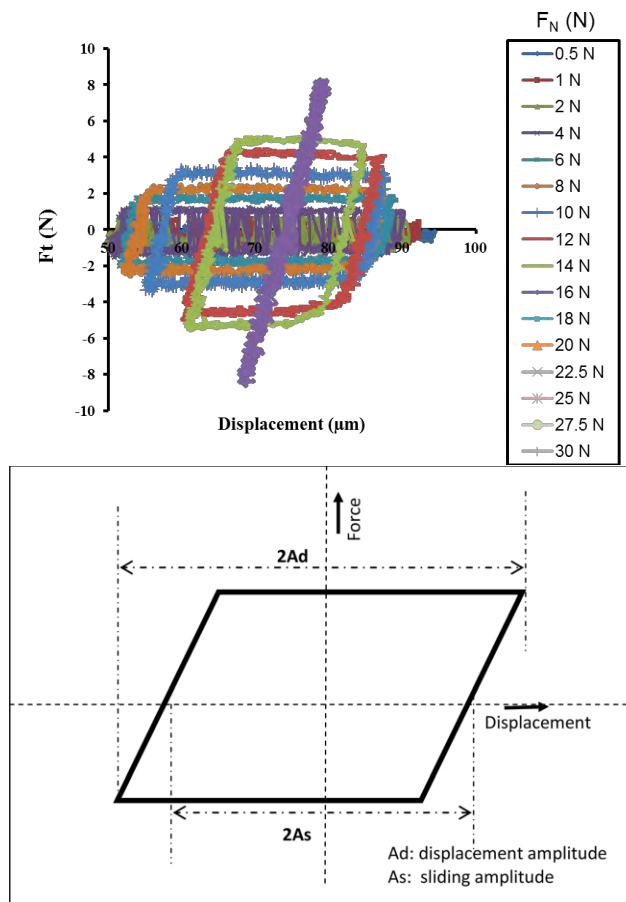
Figure 82: Characteristic elastic-sliding response hysteresis loop (right image, [170]) was observed in the current study (left image). The sliding amplitude at a given normal load can be directly measured from the F_t vs. displacement graph.

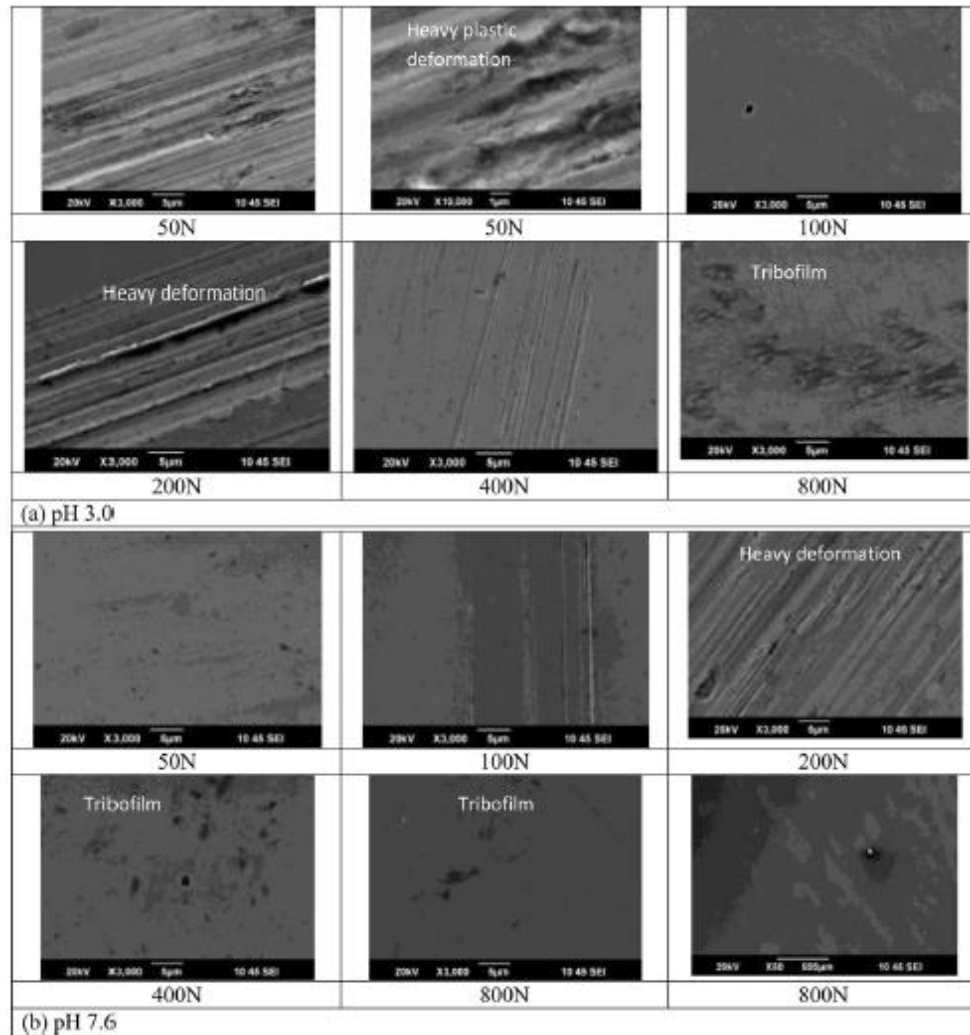
Figure 83: SEM images from a study investigating the effect of load and pH on fretting-corrosion [170]. They have observed tribofilm formation at high loads.

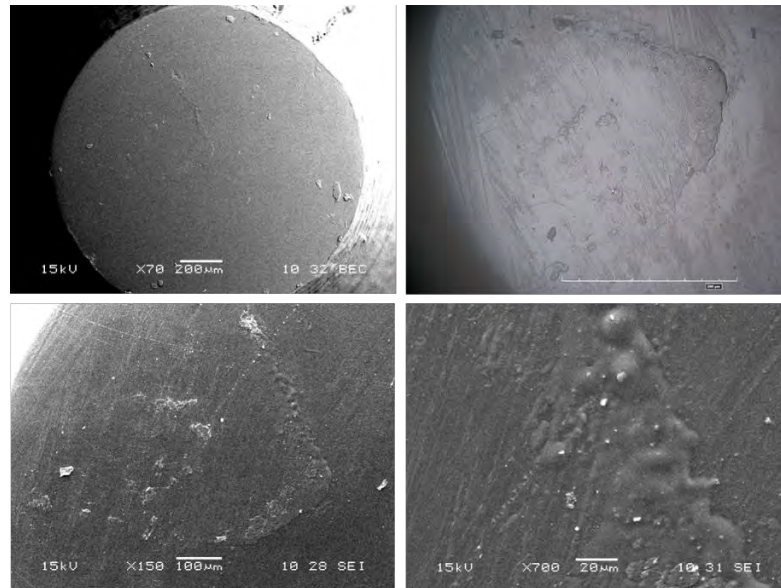
Figure 84: SEM and HIROX microscopy of PEEK pin surface after testing. There appears to be some type of film formation surrounding the surface that has evidence of mechanical wear. The exact composition and process of formation of this film is unknown, let alone the role it plays during the fretting-corrosion tests. We would like to note; however, that we observed this film on all three PEEK pins post testing and on none of the metal surfaces.

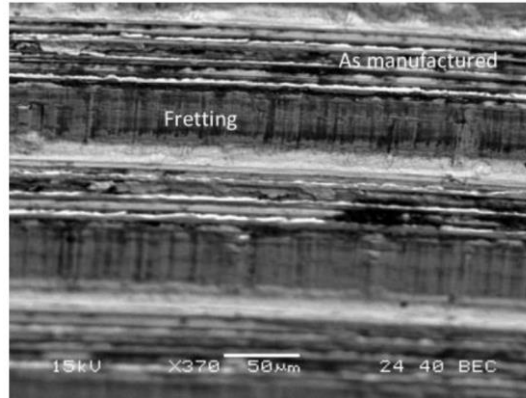
Figure 85: Also Figure 41 from Chapter 3, SEM image taken in distal portion of metal head taper showing fretting in regions with horizontal bands of material loss. Bands of material loss most likely corresponded to regions in contact with trunnion as-manufactured grooves (370x, BEC).

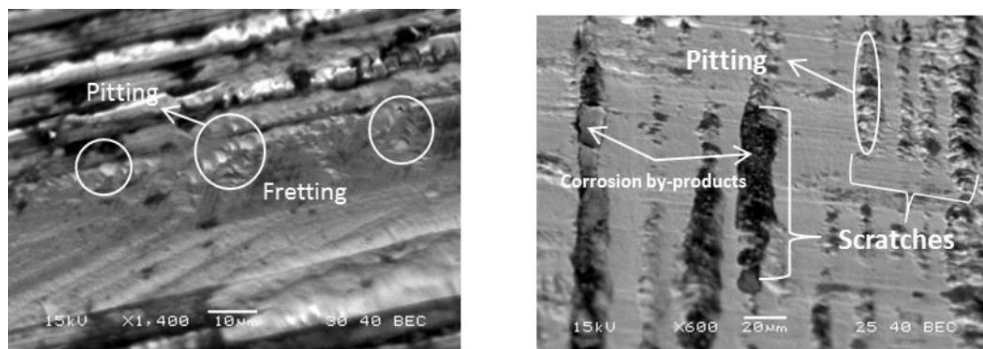
Figure 86: Also Figure 42 from Chapter 3, a component showing pitting corrosion (marked in white circles) initiated preferentially in a crevice formed due to fretting abrasion (5-40µm scratches), imaged midway between proximal and distal ends on the
