Do Ceramic Femoral Heads Reduce Taper Fretting Corrosion in Hip Arthroplasty? A Retrieval Study

Steven M. Kurtz PhD, Sevi B. Kocagöz BS, Josa A. Hanzlik MS,
Richard J. Underwood PhD, Jeremy L. Gilbert PhD, Daniel W. MacDonald MS,
Gwo-Chin Lee MD, Michael A. Mont MD, Matthew J. Kraay MD,
Gregg R. Klein MD, Javad Parvizi MD, Clare M. Rimnac PhD

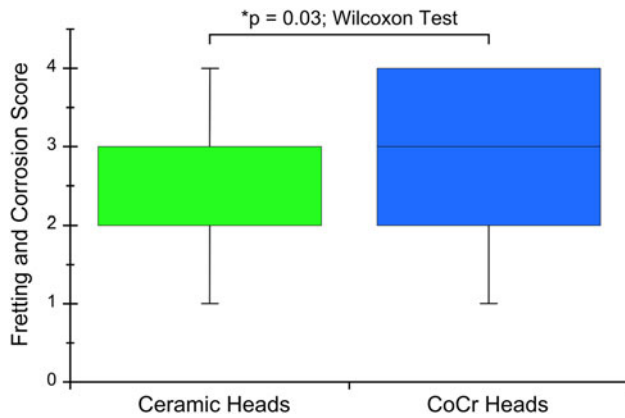
Fig. 1 The femoral stem taper fretting and corrosion damage scores for the matched ceramic and CoCr head cohorts are shown. The damage scores were significantly lower for the ceramic cohort ($p = 0.03$).

Fretting and corrosion scores were lower for the stems in the ceramic-metal when compared with the metal-metal taper cohort ($p = 0.03$; Fig. 1). Evidence of fretting and corrosion, consistent with a score of 2 or greater, was observed in 42 of 50 (84%) stems in the ceramic-metal and 42 of 50 (84%) stems in the metal-metal taper cohort. The median damage score for the stems in the ceramic-metal taper cohort was 2 (Figs. 1, 2), whereas for stems in the metal-metal taper cohort, the median score was 3 (Figs. 1, 3). We observed dark corrosion deposits outside the head-neck taper junctions in three of 50 (6%) of the metal-metal taper cohort and zero of 50 (0%) of the ceramic-metal taper cohort.

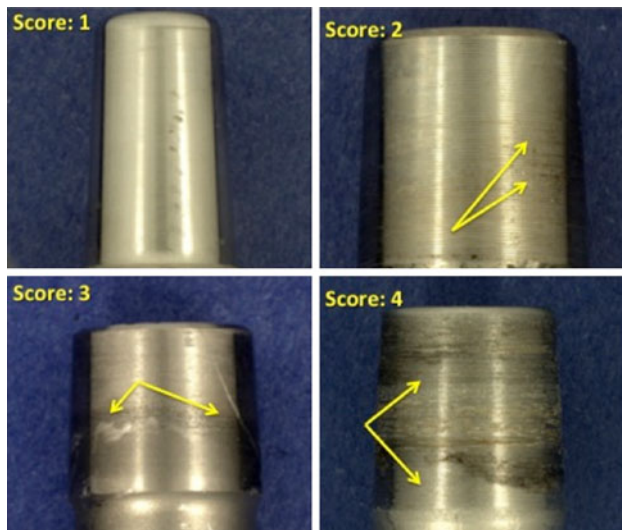
Fig. 2 Some examples of stem taper fretting and corrosion scores for the ceramic head cohort are shown. The median score for this cohort was 2.

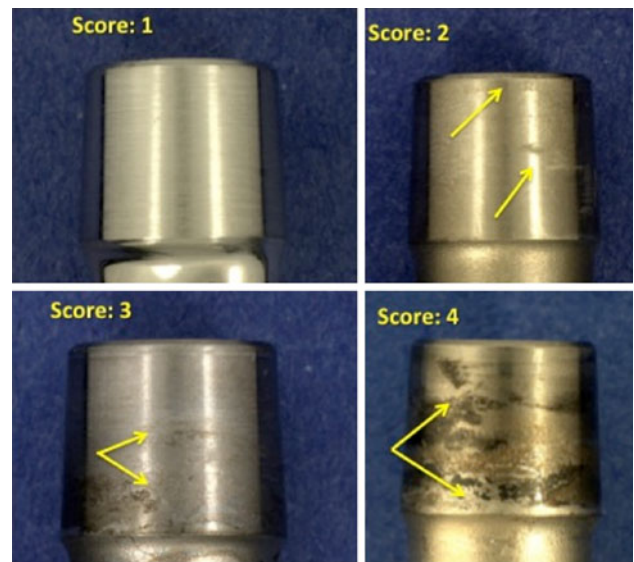
Fig. 3 Examples of stem taper fretting and corrosion scores for the CoCr head cohort are shown. The median score for this cohort was 3.

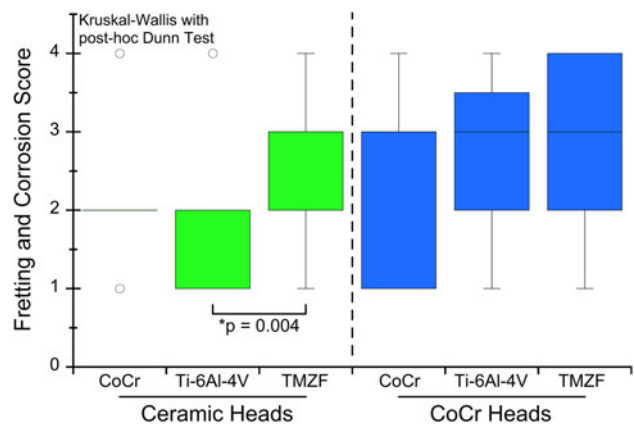
Fig. 4 A boxplot illustrating femoral stem taper fretting and corrosion score versus stem alloy for the ceramic and metal head cohorts is presented.

Both stem alloy ($p = 0.004$; Kruskal-Wallis test with post hoc Dunn Test; Fig. 4) and decreased stem flexural rigidity (Spearman's $\rho = -0.35$, $p = 0.01$) were predictors of stem fretting and corrosion damage for the ceramic-metal

taper cohort however, these variables did not have an effect for the metal-metal taper cohort (Fig. 4). Stem corrosion for the ceramic-metal taper cohort was not significantly affected by implantation time ($p = 0.46$), lateral offset ($p = 0.35$), head size ($p = 0.26$), type of ceramic bearing ($p = 0.82$), or the ceramic material formulation ($p = 0.93$). However, these tests were generally underpowered (power $< 25\%$). The only variable in this study that was a significant predictor of the metal transfer score inside the ceramic heads was decreased flexural rigidity (Spearman's $\rho = -0.35$, $p = 0.01$). For the metal head cohort, none of the patient or device variables in this study was a significant predictor of the stem corrosion for the metal-metal taper cohort. Patient weight was positively correlated with stem fretting and corrosion scores in the

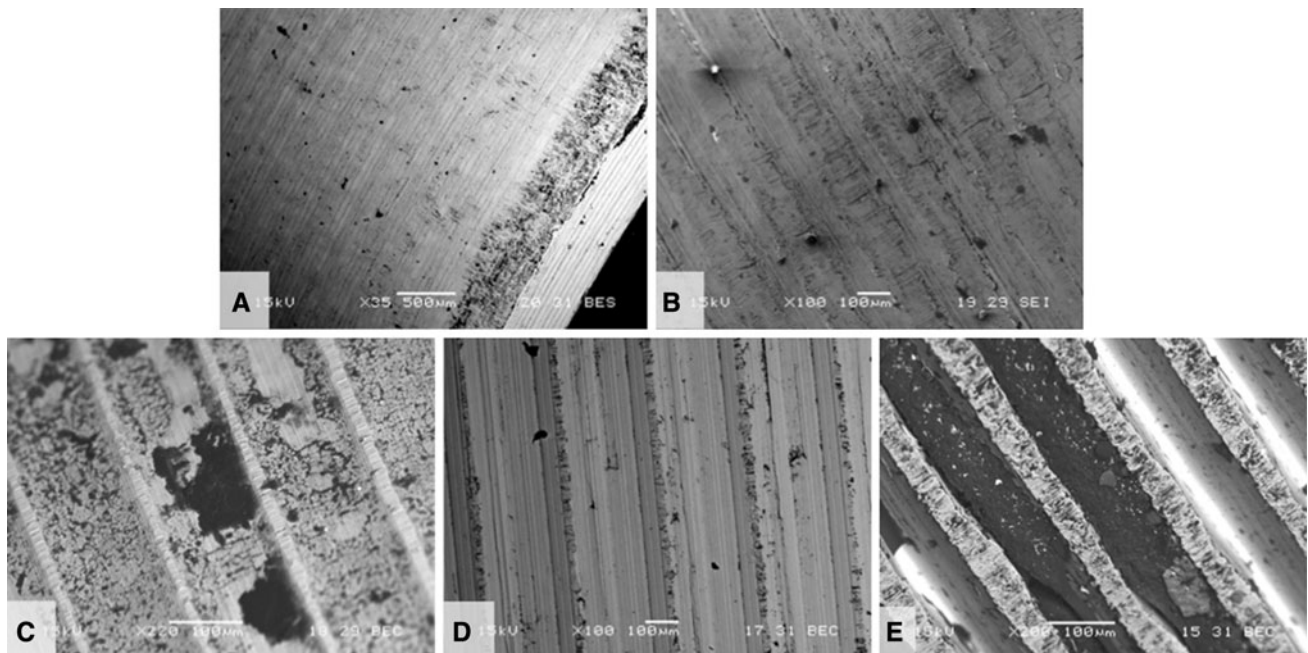
Fig. 5A–E SEMs of five different design and materials for the male taper of ceramic-metal trunnions. (A) TMZF (Stryker Orthopaedics, Mahwah, NJ, USA) \times 35 BEC, (B) Ti-6Al-4V (Zimmer, Inc, Warsaw, IN, USA) \times 100 SEI, (C) Ti-6Al-4V (Wright Medical Technology, Inc, Arlington, TN, USA) \times 220 BEC, (D) Co-Cr-Mo (DePuy Orthopaedics, Inc, Warsaw, IN, USA) \times 100 BEC,

(E) Co-Ni-Cr-Mo (Zimmer) \times 100 BEC. SEI = secondary electron imaging; BEC = backscattered electron contrast image. A is a ground surface, whereas B–E have machining grooves present. Also shown are fretting scars and corrosion and biological debris present. For grooved implants, only the groove tips show evidence of fretting corrosion damage.

showed damage on each implant that was reflective of the type of metallic surface topography present. Interestingly, the surface topography for tapers was highly variable based on alloy (Co-based or Ti-based) and manufacturer. The taper surfaces were either finely machined (TMZF; Fig. 5A) or with machined grooves present (both Ti-6Al-4V, Fig. 5B–C, and CoCr, Fig. 5D–E). The geometry of the grooves varied with design in terms of grooves per length and groove depth. For example, in Figures 5D and 5E, both implants are Co-Cr-Mo based, but Figure 5E shows tightly spaced grooves approximately 150 μm apart and roughly 60 to 100 μm deep, whereas in Figure 5D, the grooves are approximately 500 μm apart and 50 μm deep. The fretting corrosion damage seen in these tapers is intermittently distributed over the tapers and where grooves are present occur only at the top of the groove. With deep grooves, debris can accumulate (Fig. 5E) adjacent to the fretting damage. For the device in Figure 5A, the majority of fretting corrosion damage is seen in the proximal taper region (lower right of micrograph) indicating rim loading. Evidence of fretting damage and corrosion debris (dark regions) was observed on titanium alloy surfaces (Fig. 6A–B). Different types of machining grooves on cobalt alloy surfaces (Fig. 6C–D) exhibited different appearances. In one case (Fig. 6C), the damage seen has a distinct (solely) corrosion-based appearance, whereas another case (Fig. 6D) showed evidence of both fretting and corrosion damage.

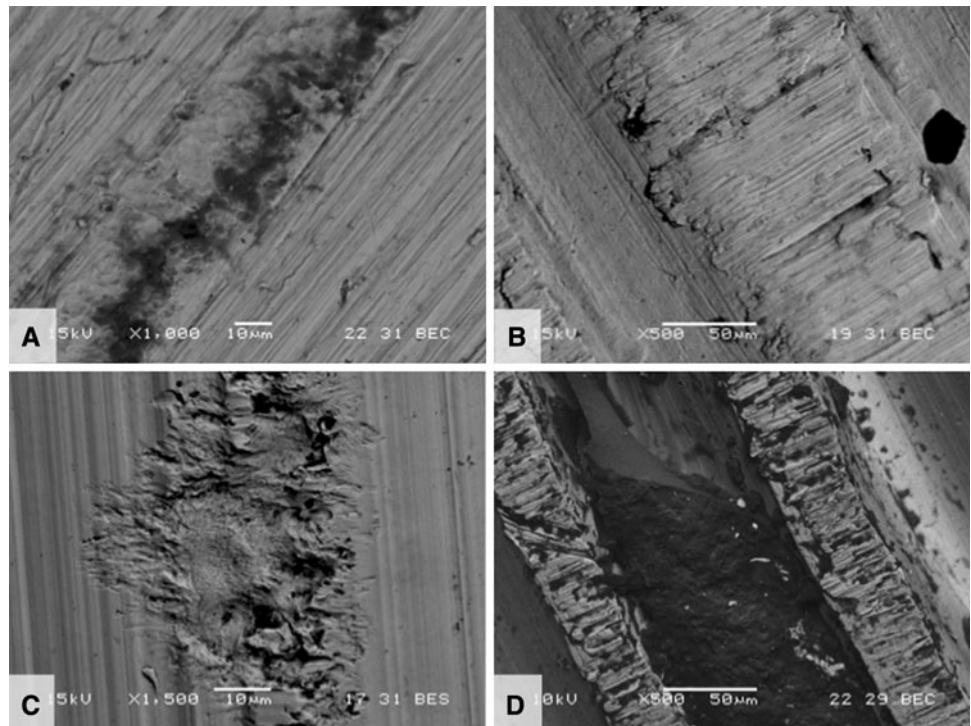
Fig. 6A–D Backscattered electron micrographs of (A) TMZF, (B) Ti-6Al-4V, (C) Co-Cr-Mo, and (D) CoNiCrMo alloy tapers used in conjunction with ceramic femoral heads. Each image shows fretting damage and some corrosion debris present. In C, the damage has a distinctly corrosion-like appearance emanating from a machining ridge.
